Virgin River

Stability Study Update

Washington County, Utah

October 2007

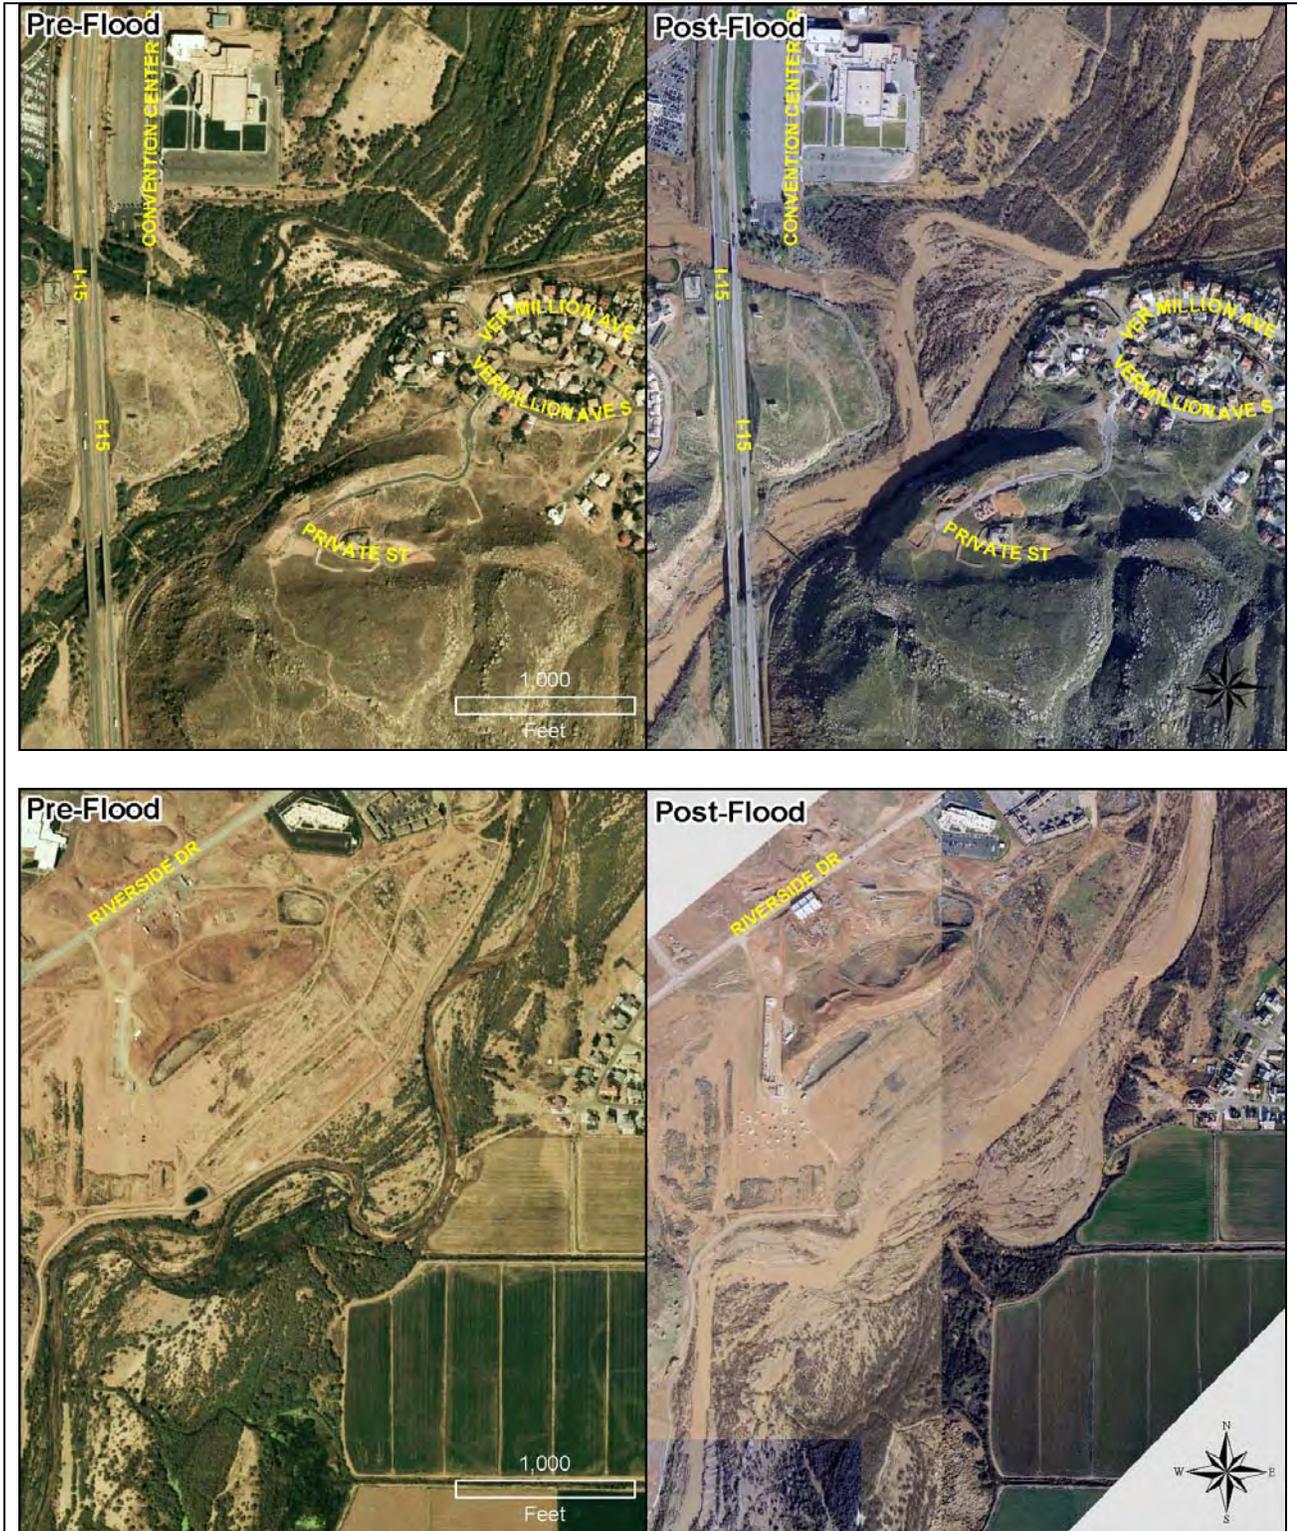
Figure 3. Examples of changes in floodplain vegetation from the 2005 flood

A significant amount of bank and floodplain vegetation was lost during the 2005 flood as a result of channel widening and overbank flows. Although pre-flood aerial photography indicated dense bank vegetation throughout much of the study reach, this vegetation appeared to provide moderate to no protection from lateral erosion. This was likely due to highly erosive flow velocities confined to the narrow conveyance corridor which resulted in scour below the tamarisk rooting layer. The encroachment of vegetation on the low-flow channel was likely caused by persistent years of drought, combined with a lower frequency of moderate to large flood events. The result was a narrow channel that was densely vegetated along both the banks and the floodplain. The active channel width in 2004 was narrower than any other time in the period of record, a direct result of repeated low-flow years and tamarisk encroachment.

The 2005 flood demonstrated that when a large-magnitude, low frequency flood occurs during this condition, the narrow channel is insufficient to convey the flow, thus must create a wider conveyance corridor. This process removes bank vegetation and creates vertical, unstable cutbanks. These processes occurred during the 2005 flood. The plot of USGS peak flow values shown in Figure 2 indicates a series of low-flow years from 2000 to 2004. This resulted in a narrow, over-grown channel insufficient for conveying a discharge of 19,600 cfs (peak 2005 flood). Figure 3 shows typical examples of pre- and post-flood channel and bank vegetation conditions within the study reach. The presence of tamarisk generally does not prevent lateral

erosion, and may actually result in higher susceptibility of erosion during some types of channel avulsions.

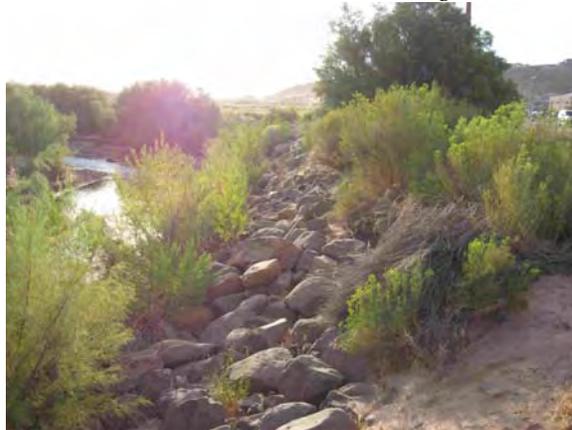
Photo ID: 8-31-2006-64

Failed/failing rip-rap bank protection. Riprap bank protection has been placed in several locations along the study reach, and is beginning to fail upstream of River Road along 1450 South and near the Interstate 15 bridges.

Bank protection along River Road near 1450 South

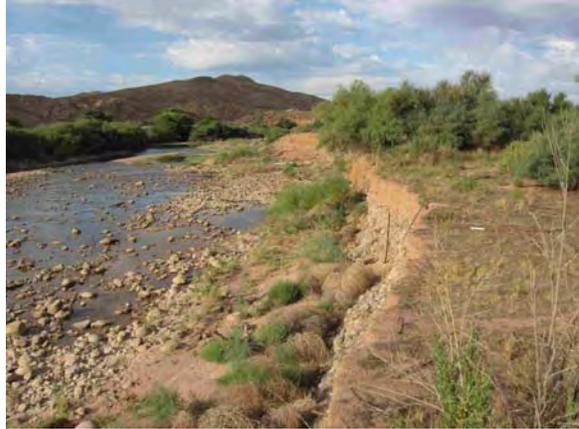
Photo ID: 8-31-2006-207

Vertical cut banks. Vertical cut banks were the dominant bank condition observed throughout the study reach. Vertical cut banks are indicative of rapid lateral channel movement, long-term scour, and unstable channels.

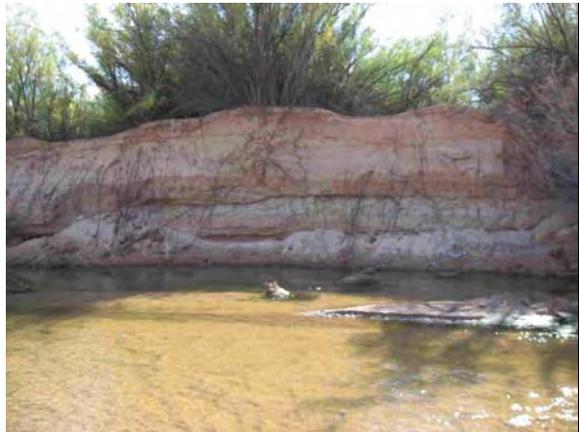
Photo ID: 8-30-2006-60

Undercut banks. Undercut banks were observed where tamarisk or other brushy vegetation was growing in dense thickets above vertical banks. The root network of the vegetation provides a limited degree of stability to the tops of the sandy bank soils and temporarily prevents its collapse. Undercut banks are indicative of rapid lateral channel movement and unstable channels.

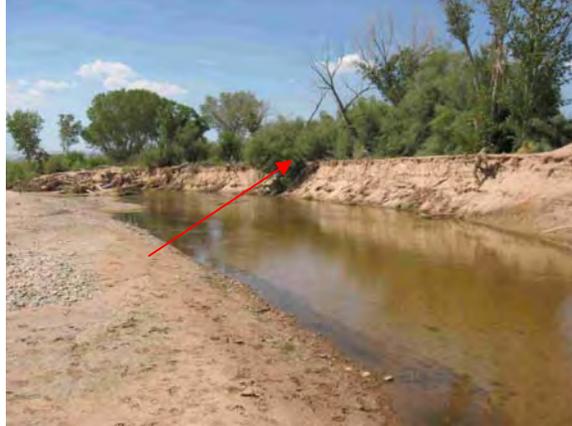
Photo ID: 8-30-2006-17

Tipped bank vegetation. Tipped bank vegetation is indicative of lateral erosion undercutting the banks, and was observed in numerous places throughout the study reach.

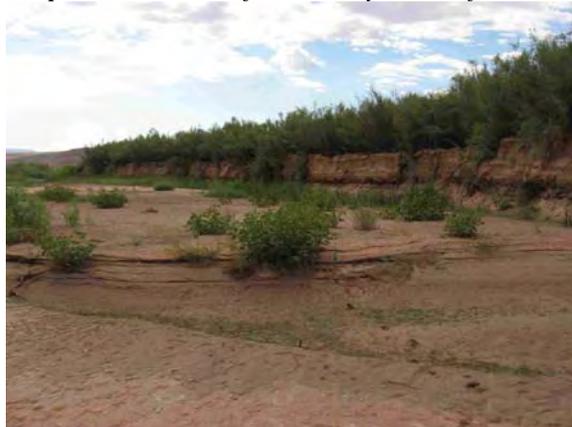
Photo ID: 9-1-2006-233

Perched bank vegetation. In general, where bank vegetation was present, it was perched above vertical or very steep banks. Vegetation becomes perched after long-term scours lower the bed elevation or when lateral channel movement erodes into elevated floodplain terraces. Because the vegetation is perched above the bankfull water surface elevation, its root mass and canopy do not protect the bank from the hydraulic forces that cause bank erosion.

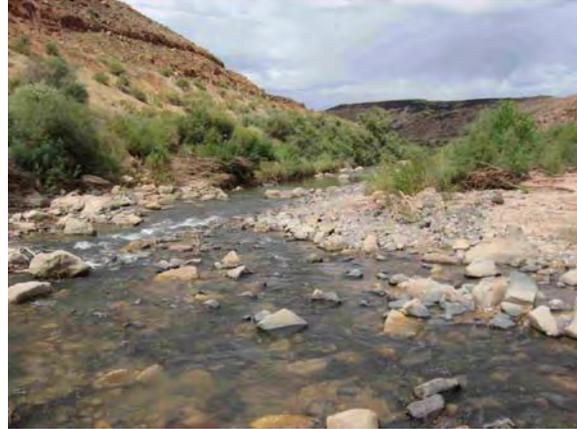
Photo ID: 9-1-2006-258
Coarse bed sediments

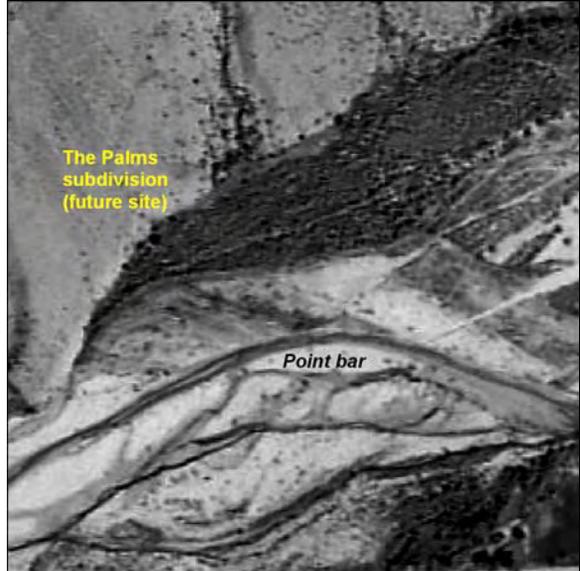
Aerial photo year: 1952
Location: near The Palms subdivision

Wide point bars. Wide point bars are found along most channel bends in the study reach. Wide point bars usually indicate rapid lateral channel movement and high bed load transport. Wide point bars form where bank erosion rates exceed the rate of re-vegetation by floodplain species. Given that the dominant form of floodplain vegetation is tamarisk, a very fast-growing plant, the rate of lateral erosion is rapid.

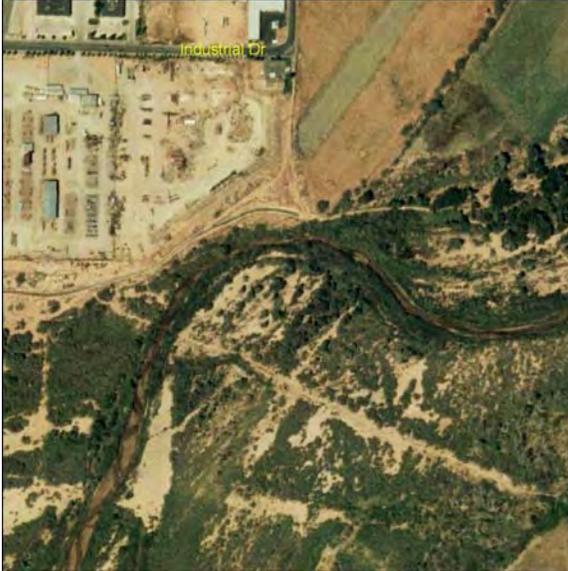
Aerial photo year: 2004 (pre-flood)
Location: near Industrial Drive and 100 E.

Tamarisk growth. Most of the active floodplain terraces and some of the medium height bars are densely vegetated with tamarisk that range in height from several feet (on topographically lower surfaces) to tens of feet (on older surfaces). Very few large deciduous trees such as cottonwood, ash, or willow were observed except where planted near homes. The tamarisk observed above vertical cut banks did not appear to provide any significant protection from bank erosion. The tamarisk on the floodplain terraces appeared to have survived recent flood inundation without substantial damage.

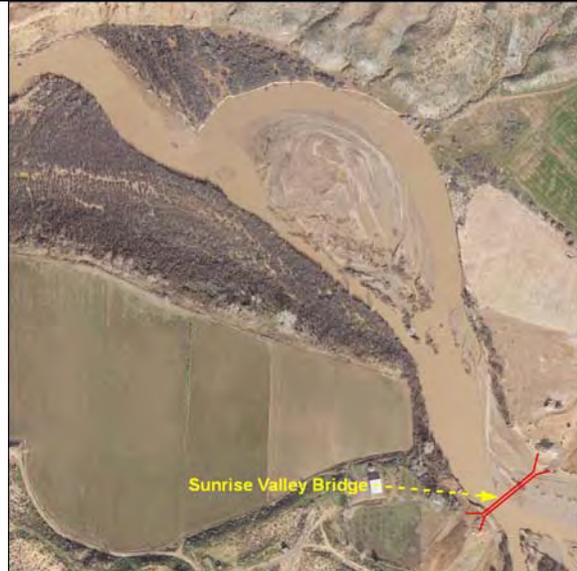
Aerial photo year: 2005 (post-flood) – loss of floodplain tamarisk
Location: Sunrise Valley Bridge

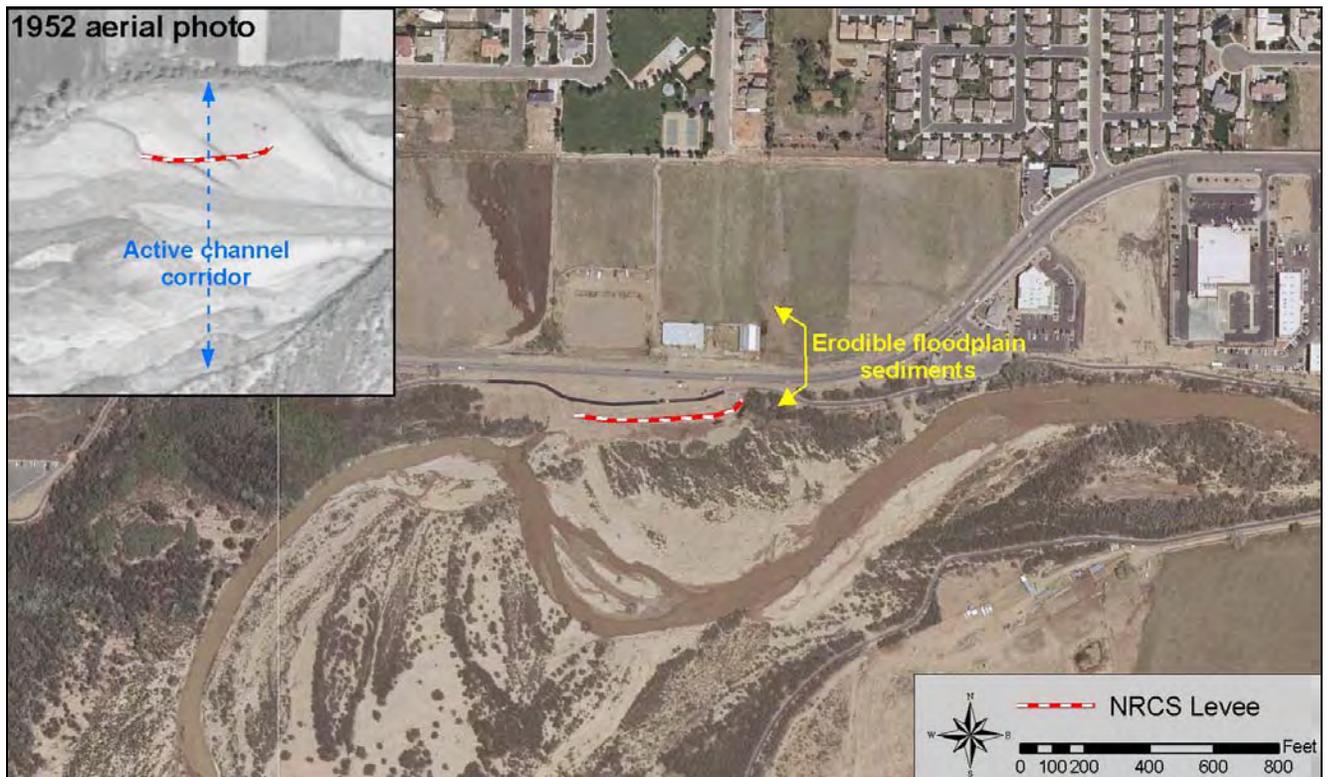
Figure 10. NRCS structure example 1

developed and began migrating toward Riverside Drive. The levee was placed to protect the roadway from erosion. The following evidence for this location was used in determining the location of the erosion hazard zone:

When considering the above described evidence, it was determined that a potential existed for the levee to be flanked during a large flood event, thus the structure was not considered to provide adequate erosion protection when determining the placement of the erosion hazard zone.

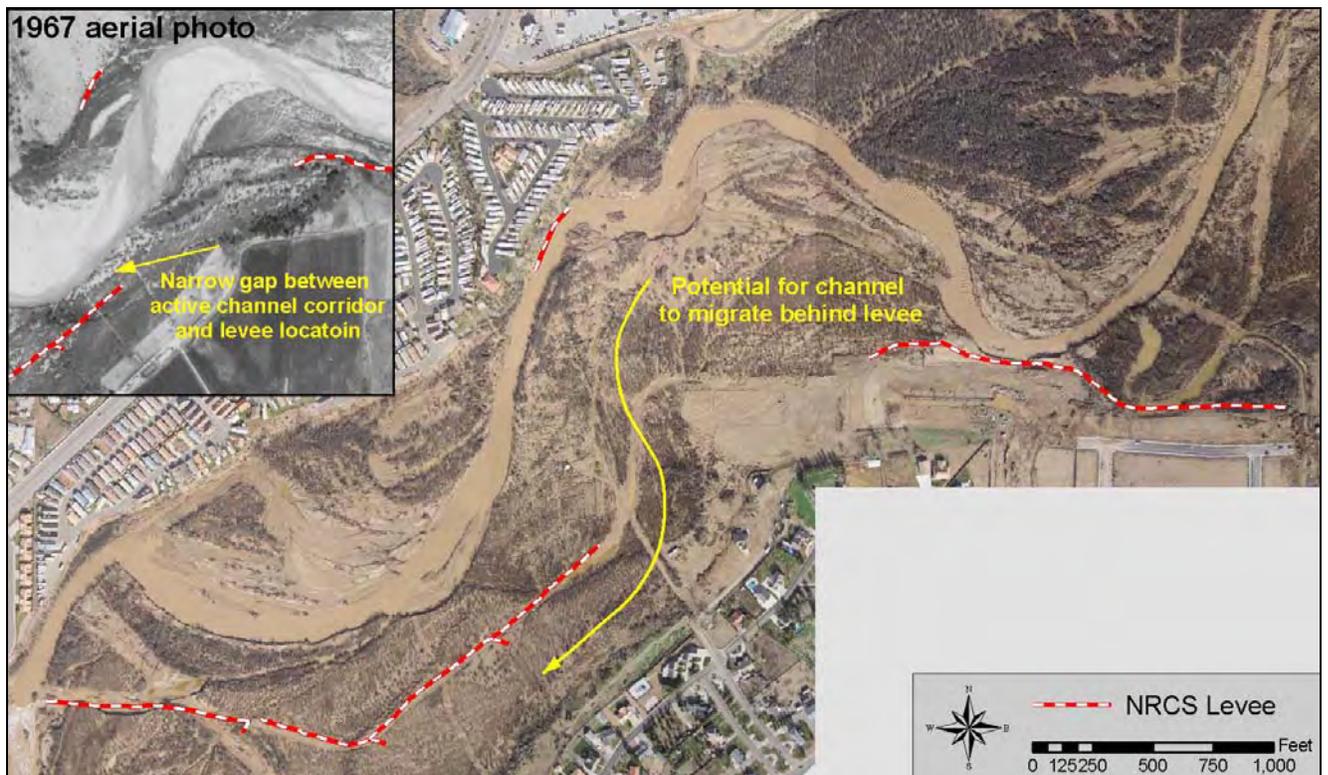
Figure 11. NRCS structure example 2

this location was used in determining the location of the erosion hazard zone:

- a. Aerial photography from 1967 shows the active channel within 200 feet of the location of the downstream levee (Figure 11).
- b. Analysis of aerial photography in this area from 1952 through 2006 indicates the active channel has been very dynamic and has migrated laterally over 1,000 feet within the past 54 years. This suggests that there is a potential for the active channel to migrate through the gap in the levee structures. If this were to occur, the channel would essentially become trapped behind the levee and could likely cause significant erosion and flood inundation damage to homes and other structures in the vicinity.
- c. The revised floodplain and floodway mapping indicate flow overtops the structure and flanks the levee.

This scenario was considered when placing the erosion hazard zone in this area. To reduce to potential for this situation, it is recommended that an additional levee section be constructed to close the 1,400 foot gap.

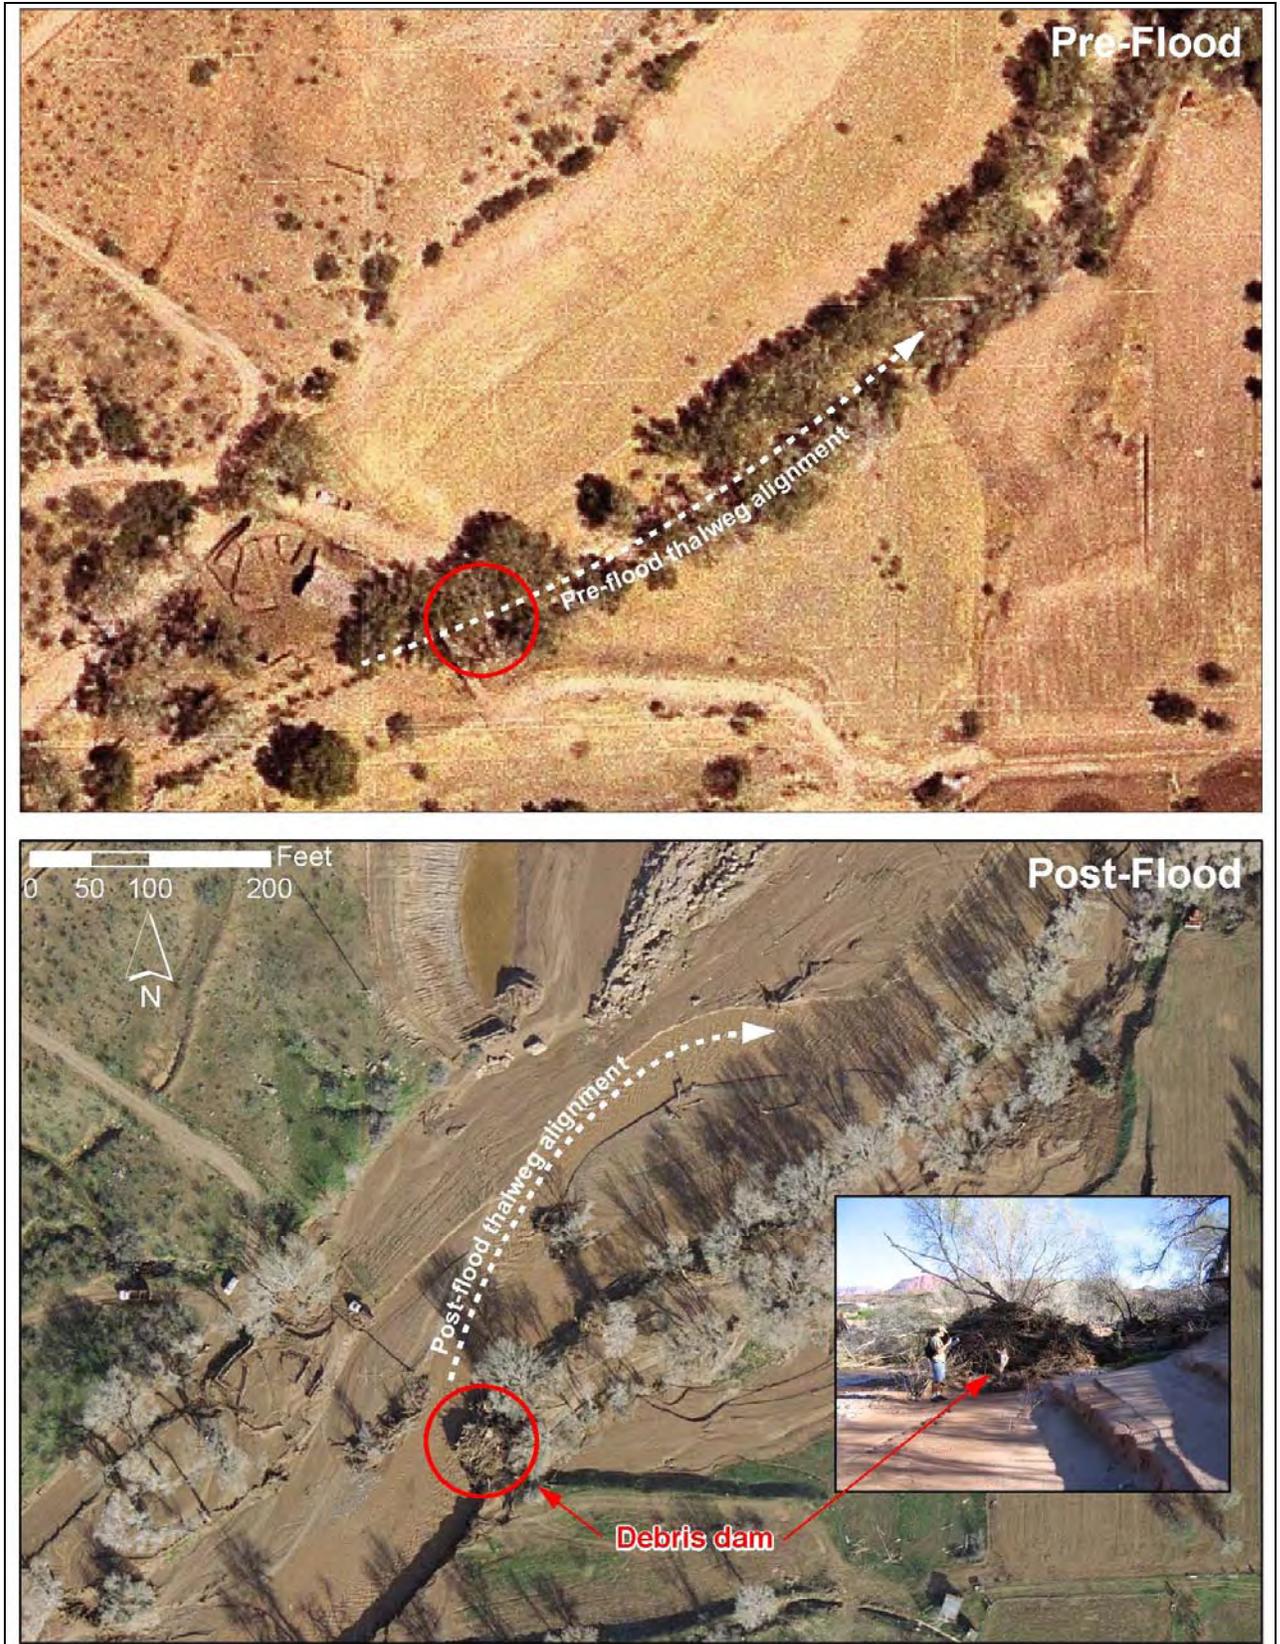
Figure 9. Debris dam in upper study area

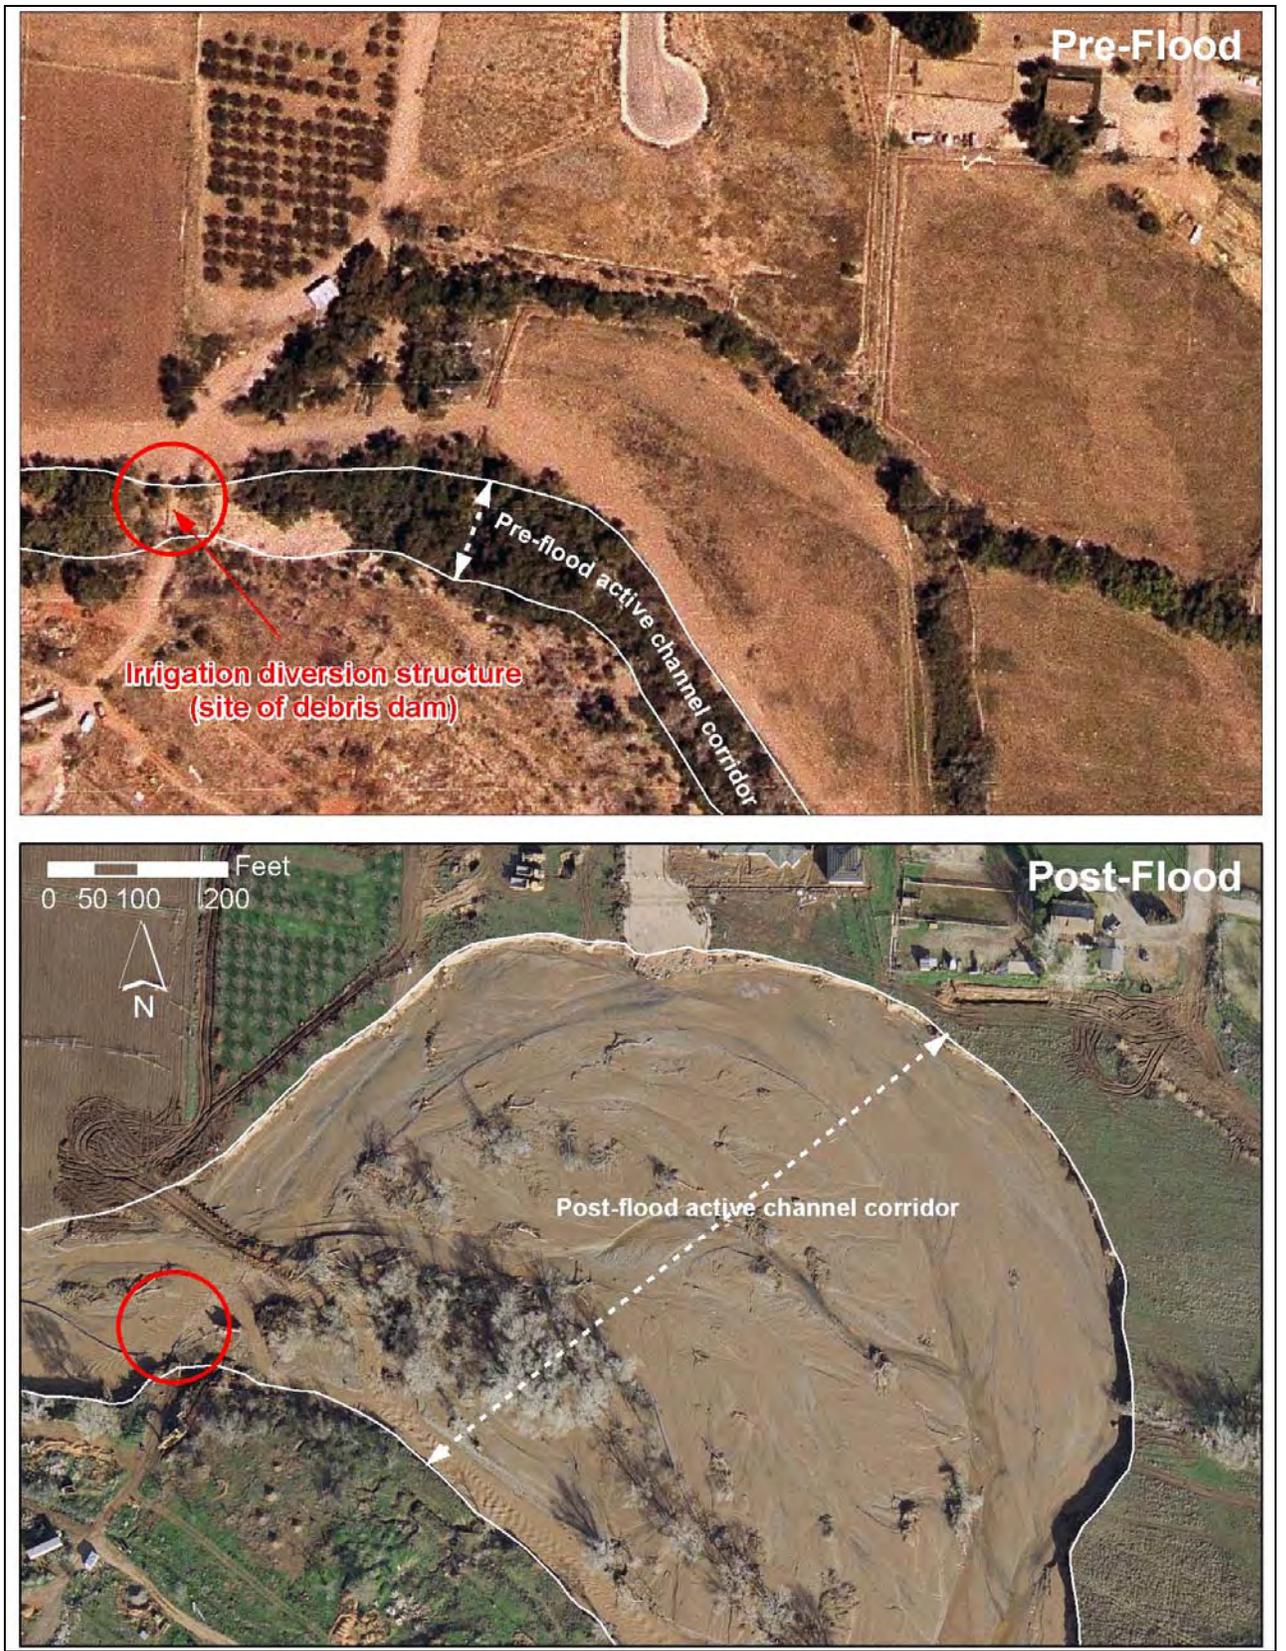
Figure 10. Debris dam at irrigation diversion structure

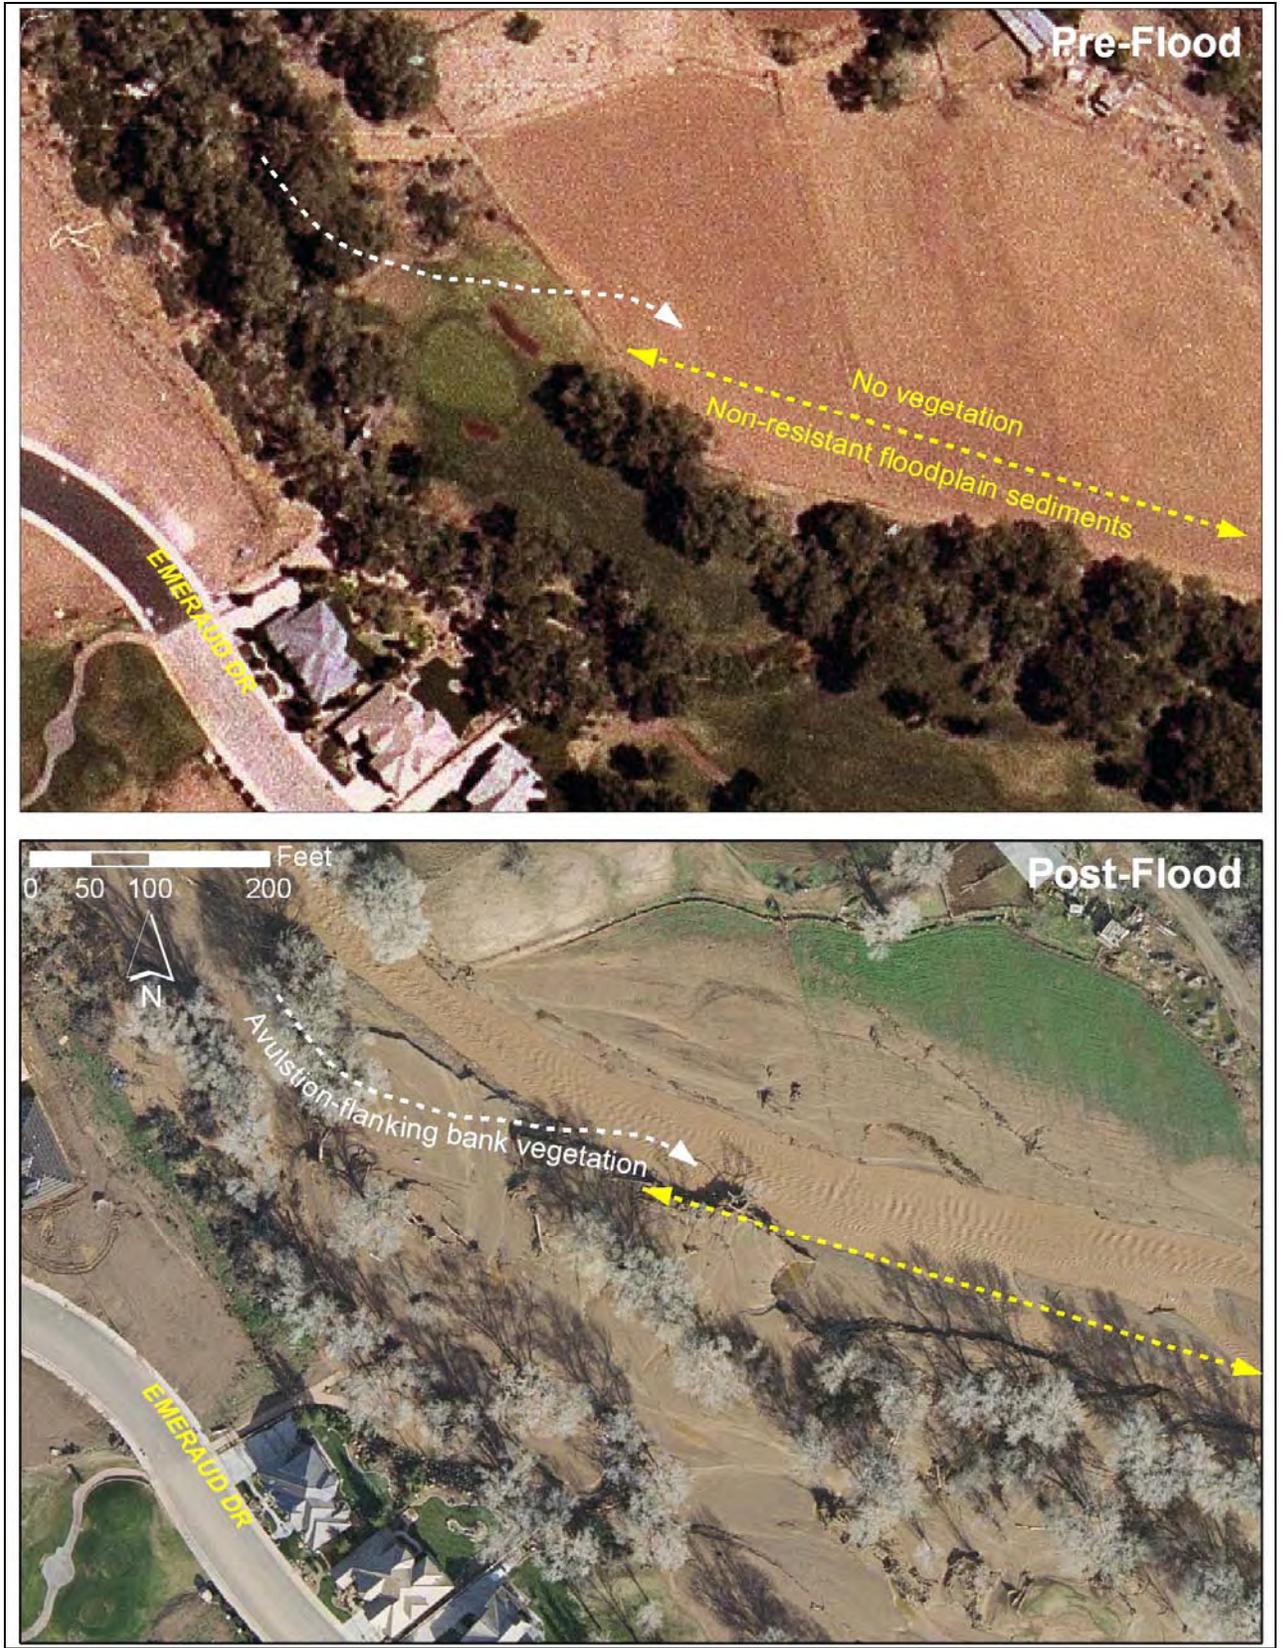
Figure 11. Example 1 - avulsion due to flanking of bank vegetation

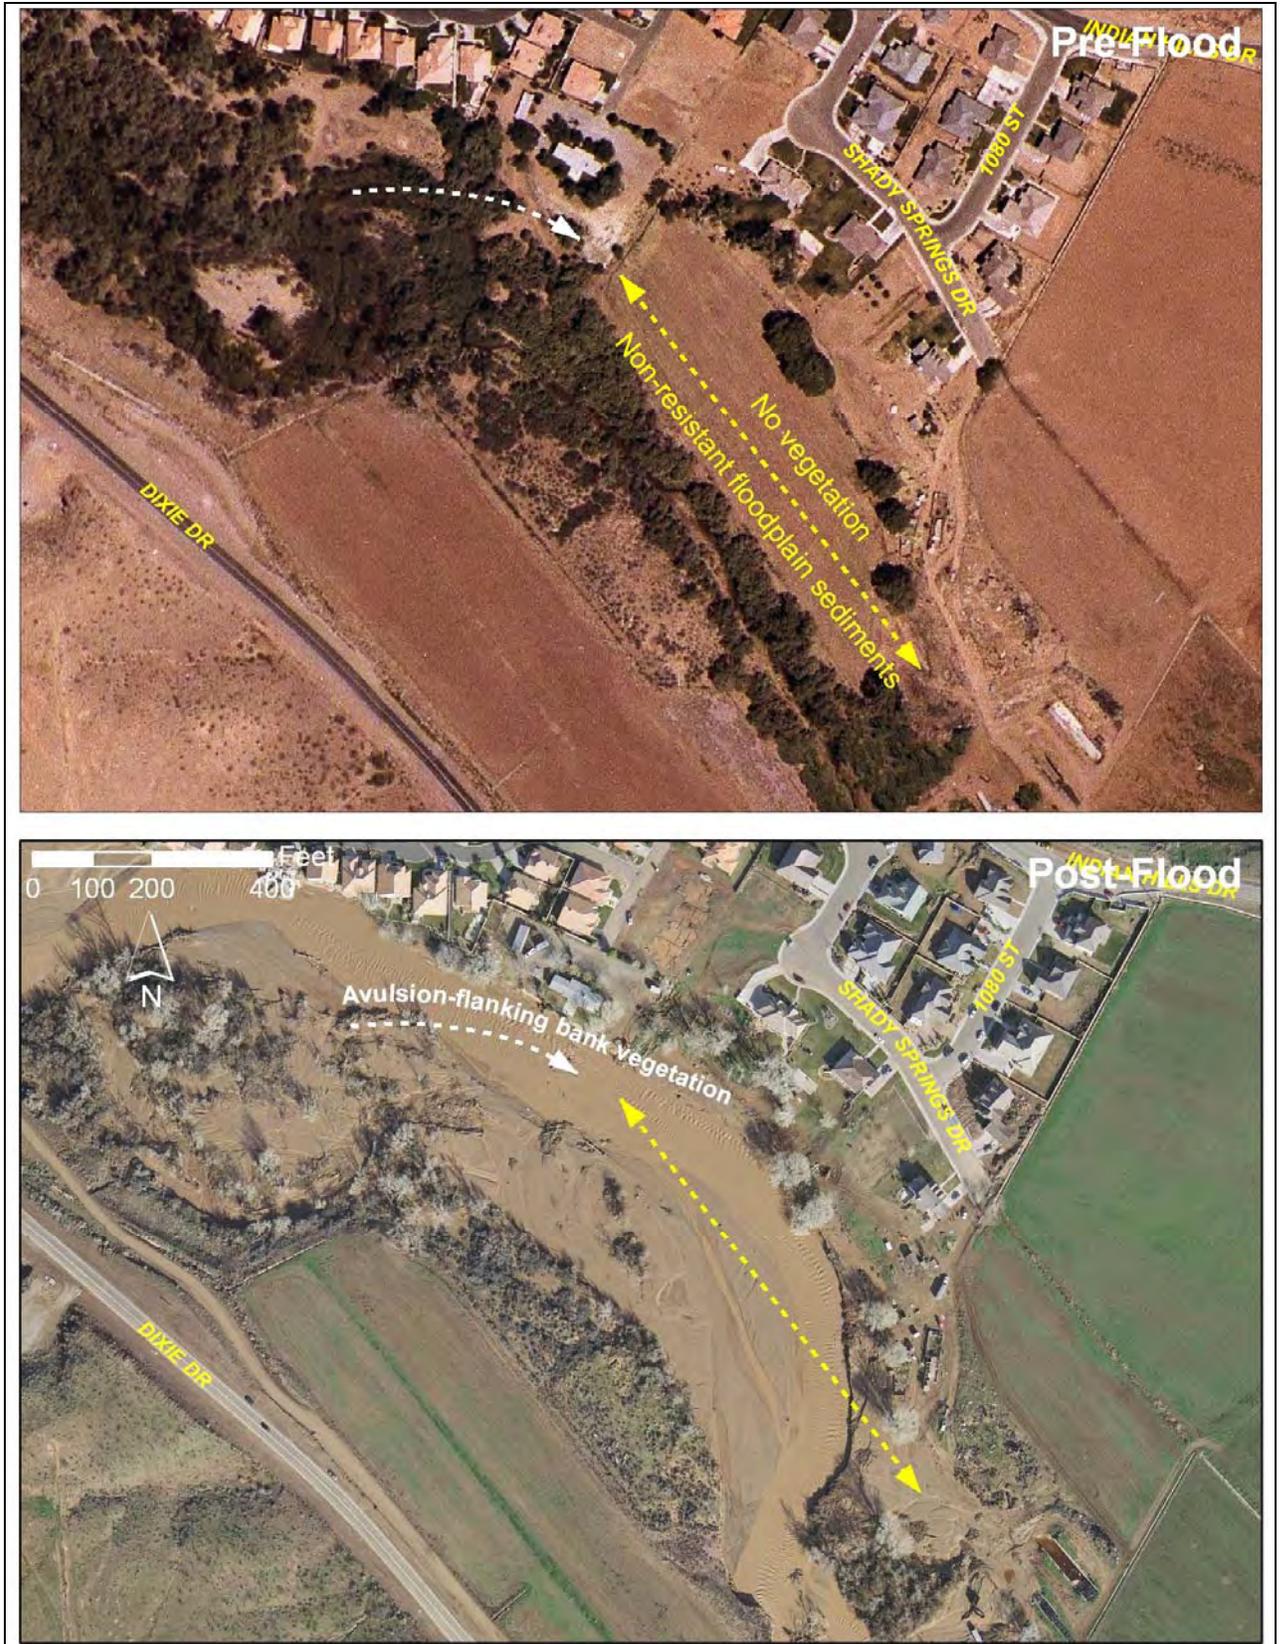
Figure 12. Example 2 - avulsion due to flanking of bank vegetation

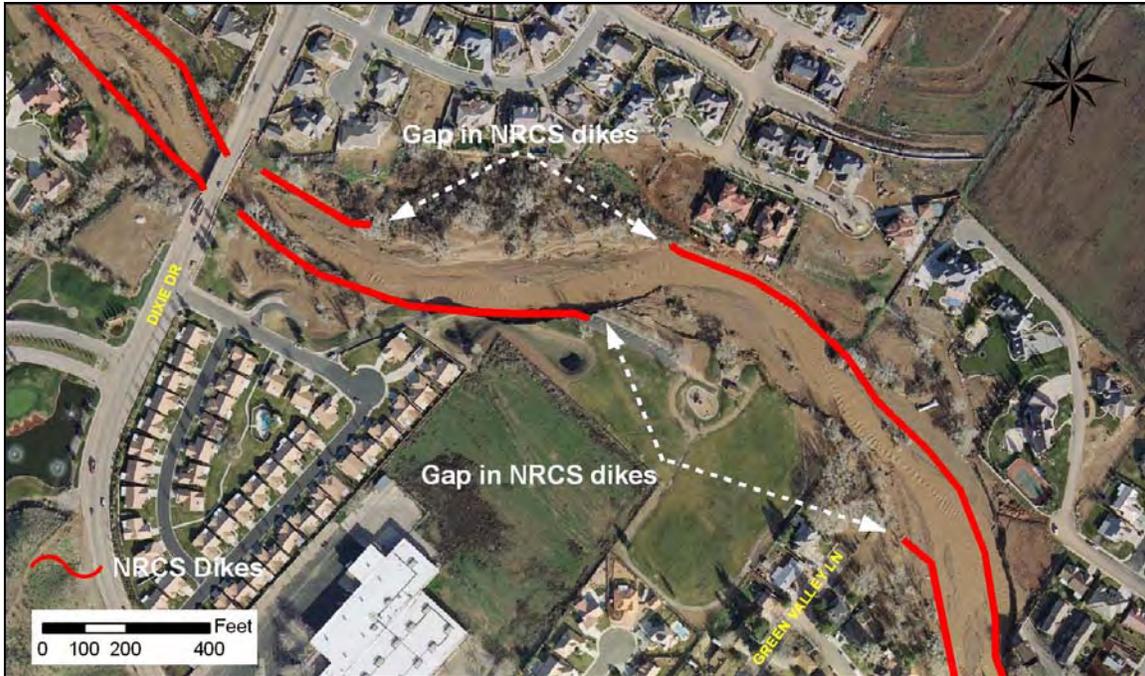
Figure 27. Examples of gaps in NRCS dikes

- *Add additional bank protection structures in areas of discontinuous NRCS dikes. Areas located within the breaks in the current NRCS dikes are potentially subject to a greater erosion hazard. Figure 27 illustrates examples of such locations.*
