Virgin River

Stability Study Update

Washington County, Utah

October 2007

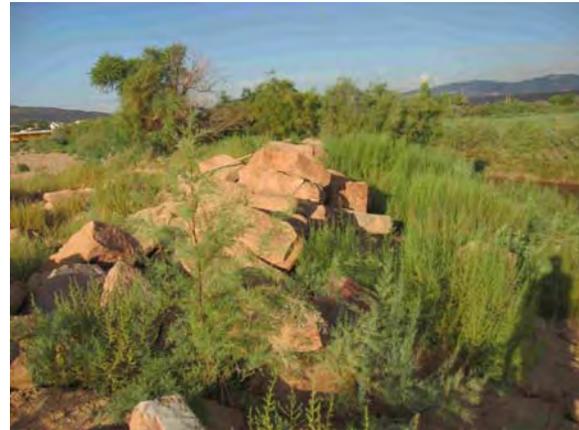
Photo ID: 8-31-2006-67

Newly placed bank protection along River Road near 1450 South

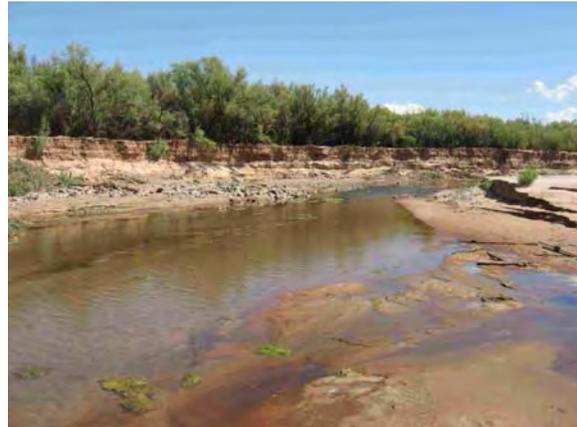
Photo ID: 8-31-2006-137

Stratified bank sediment. In general, the channel banks in the study reach are composed of stratified sand and gravel alluvium. Stratified bank sediments are generally less resistant to erosion than banks composed of uniform fine-grained sediments.

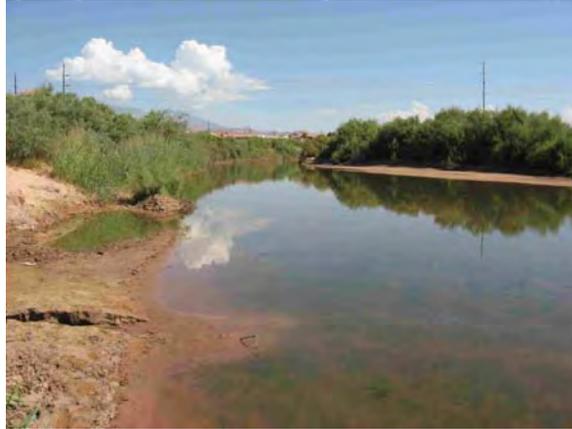
Photo ID: 8-31-2006-124
Normal bed sediments

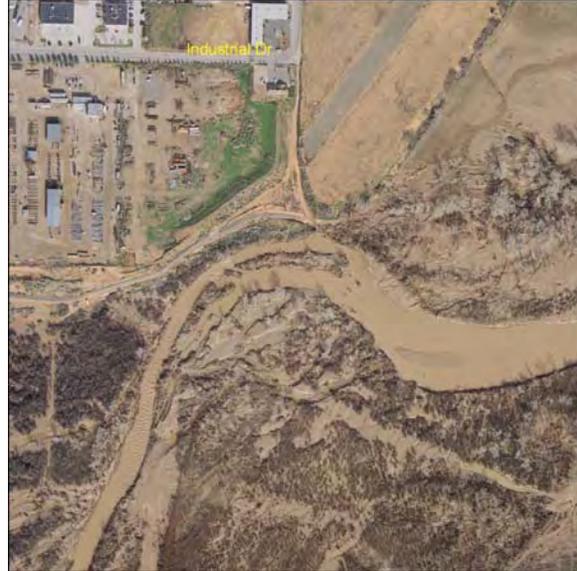
Aerial photo year: 2005 (post-flood) – loss of floodplain tamarisk
Location: near Industrial Drive and 100 E.

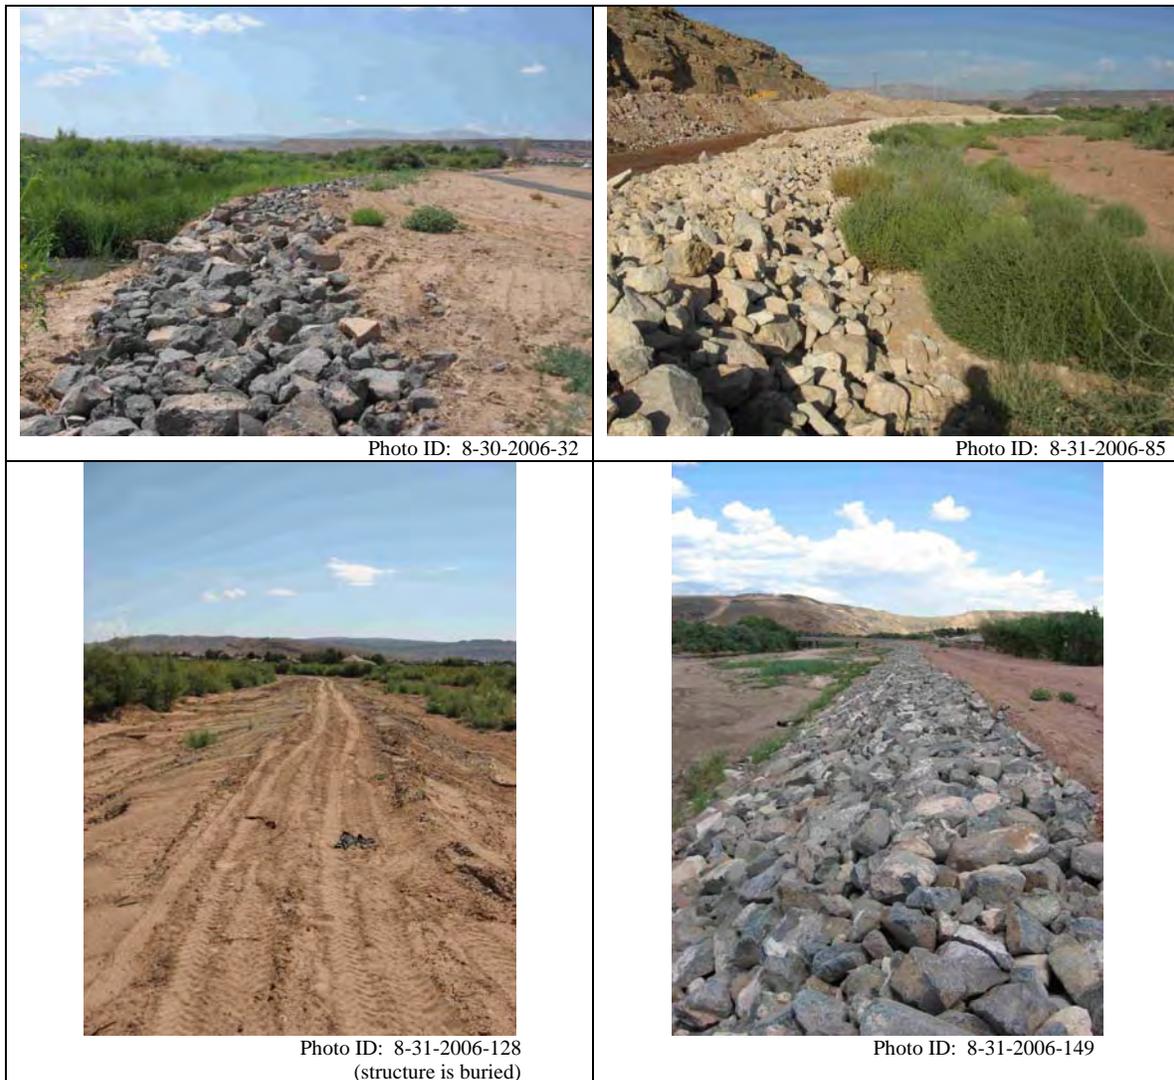
Figure 9. Photos of NRCS structures within the study reach

While construction of the NRCS erosion control measures may reduce potential future lateral migration and bank erosion in portions of the study reach, it does not eliminate erosion hazards in those reaches. Because the NRCS structures were designed for a flood less than the 100-year event, the potential for high stage flows to overtop the structures and erode behind the levees or above bank protection still exists. All of these factors were considered when delineating the erosion hazard zone. Additionally, discontinuous placement of the NRCS structures and the lack of structural tie-in to resistant bank material may provide significantly less protection from erosion than initially intended. Examples of a few of these situations are discussed below.

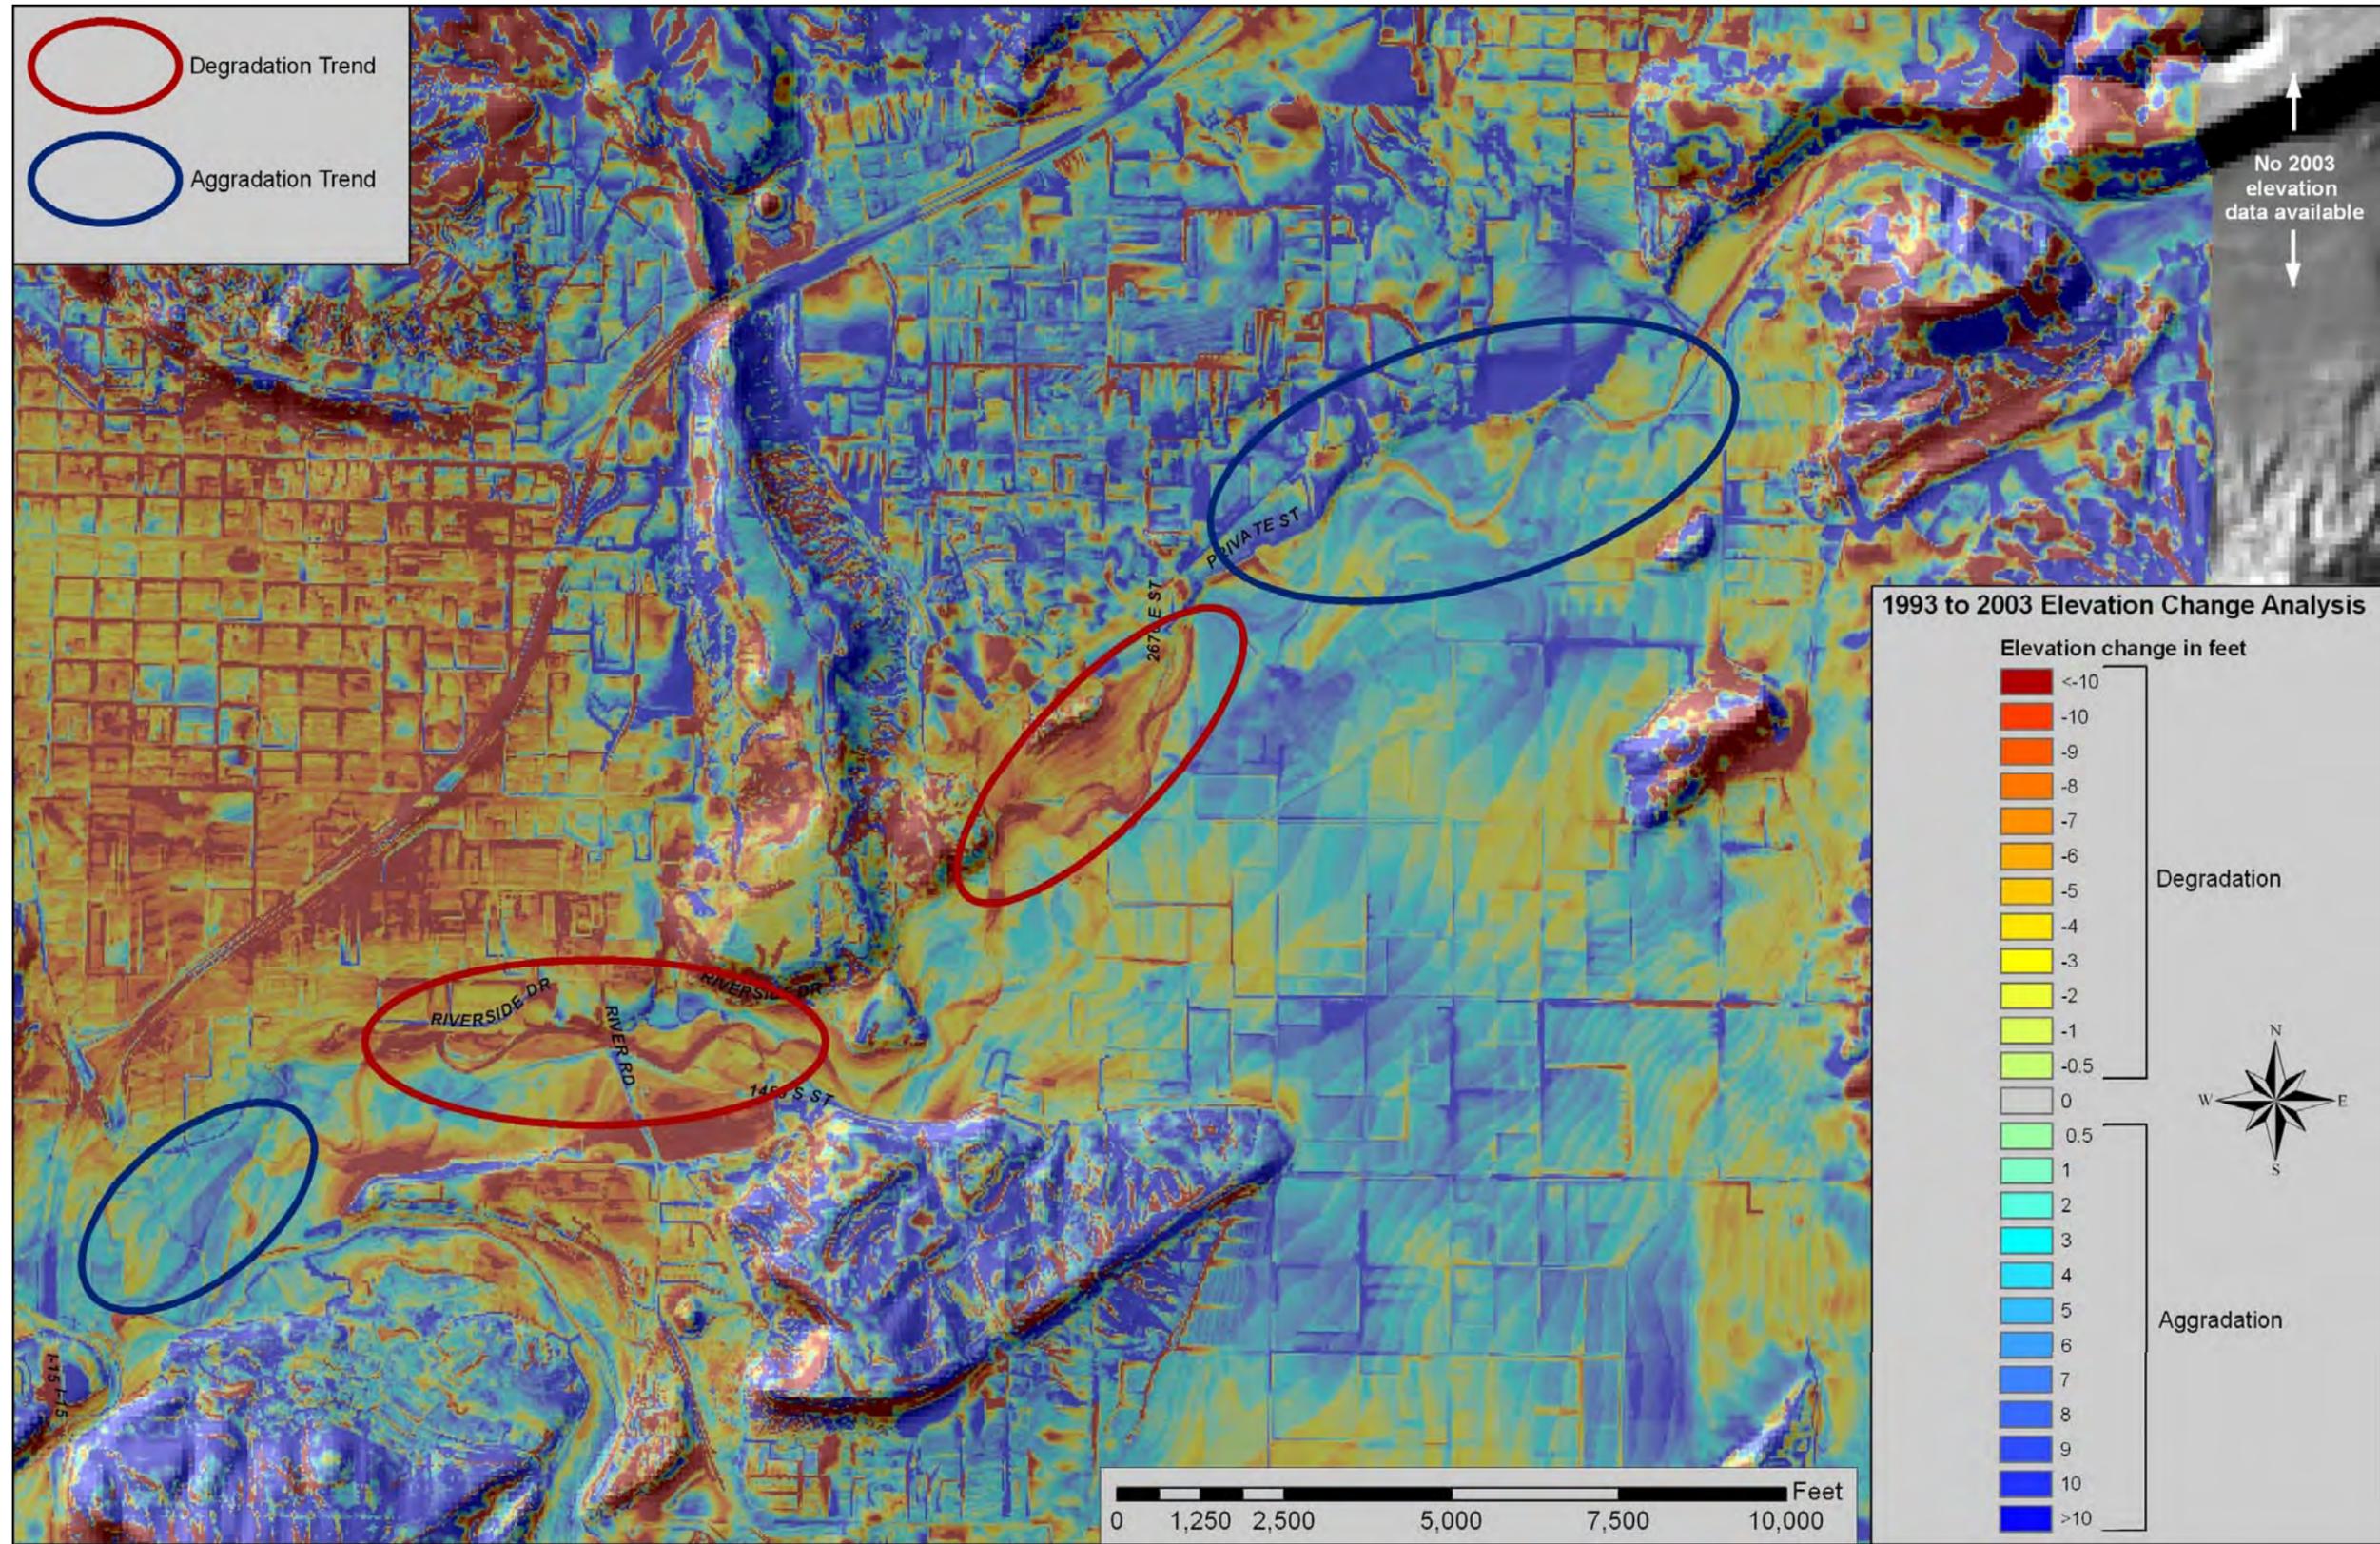
Figure 13. 1993-2003 elevation change analysis results

The results shown in Figure 13 also suggest that significant changes in elevation occurred on the large bedrock mesas such as Webt Hill near Interstate 15 and Nichols Peak near Washington Fields. The results suggest elevation changes greater than 100 feet in these areas, when in fact no such changes occurred between 1993 and 2003 as evidenced in aerial photography. One likely explanation for this discrepancy is a slight lateral shift between the two data sets. This shift would result in significant changes in elevation in areas with high relief (such as Webt Hill and Nichols Peak), but the effects would be dampened in areas of low relief (such as the Virgin River floodplain). Another possible explanation for the discrepancies shown in Figure 13 and listed in Table 8 is the significantly lower resolution of the 1993 USGS data (10 meter (32.8 ft)). The results suggest that a quantitative, site-specific estimate of elevation change should not be made with this data set. Large-scale interpretations should be made with caution. In addition to the spatial elevation change analysis, a cross-section profile comparison analysis was also conducted for the topographic data sets (described below in Section 6.1.2). The results of this analysis also suggest there are discrepancies in the accuracy of the 1993 data.

The outlined areas on Figure 13 illustrate general trends in elevation change between the two data sets. The two reaches identified as aggradation trends correspond to the densest areas of tamarisk within the study reach. These dense vegetation zones within the floodplain result in extremely high roughness values and low hydraulic energy environments which accumulate floodplain sediment over time. The result of the elevation change analysis indicates general aggradation values between one and eight feet in these areas. The discrepancy in the 1993 data discussed previously suggests that the quantitative values represented in Figure 13 should not be interpreted precisely. However, the overall trends toward aggradation and degradation shown in the figure are likely valid.

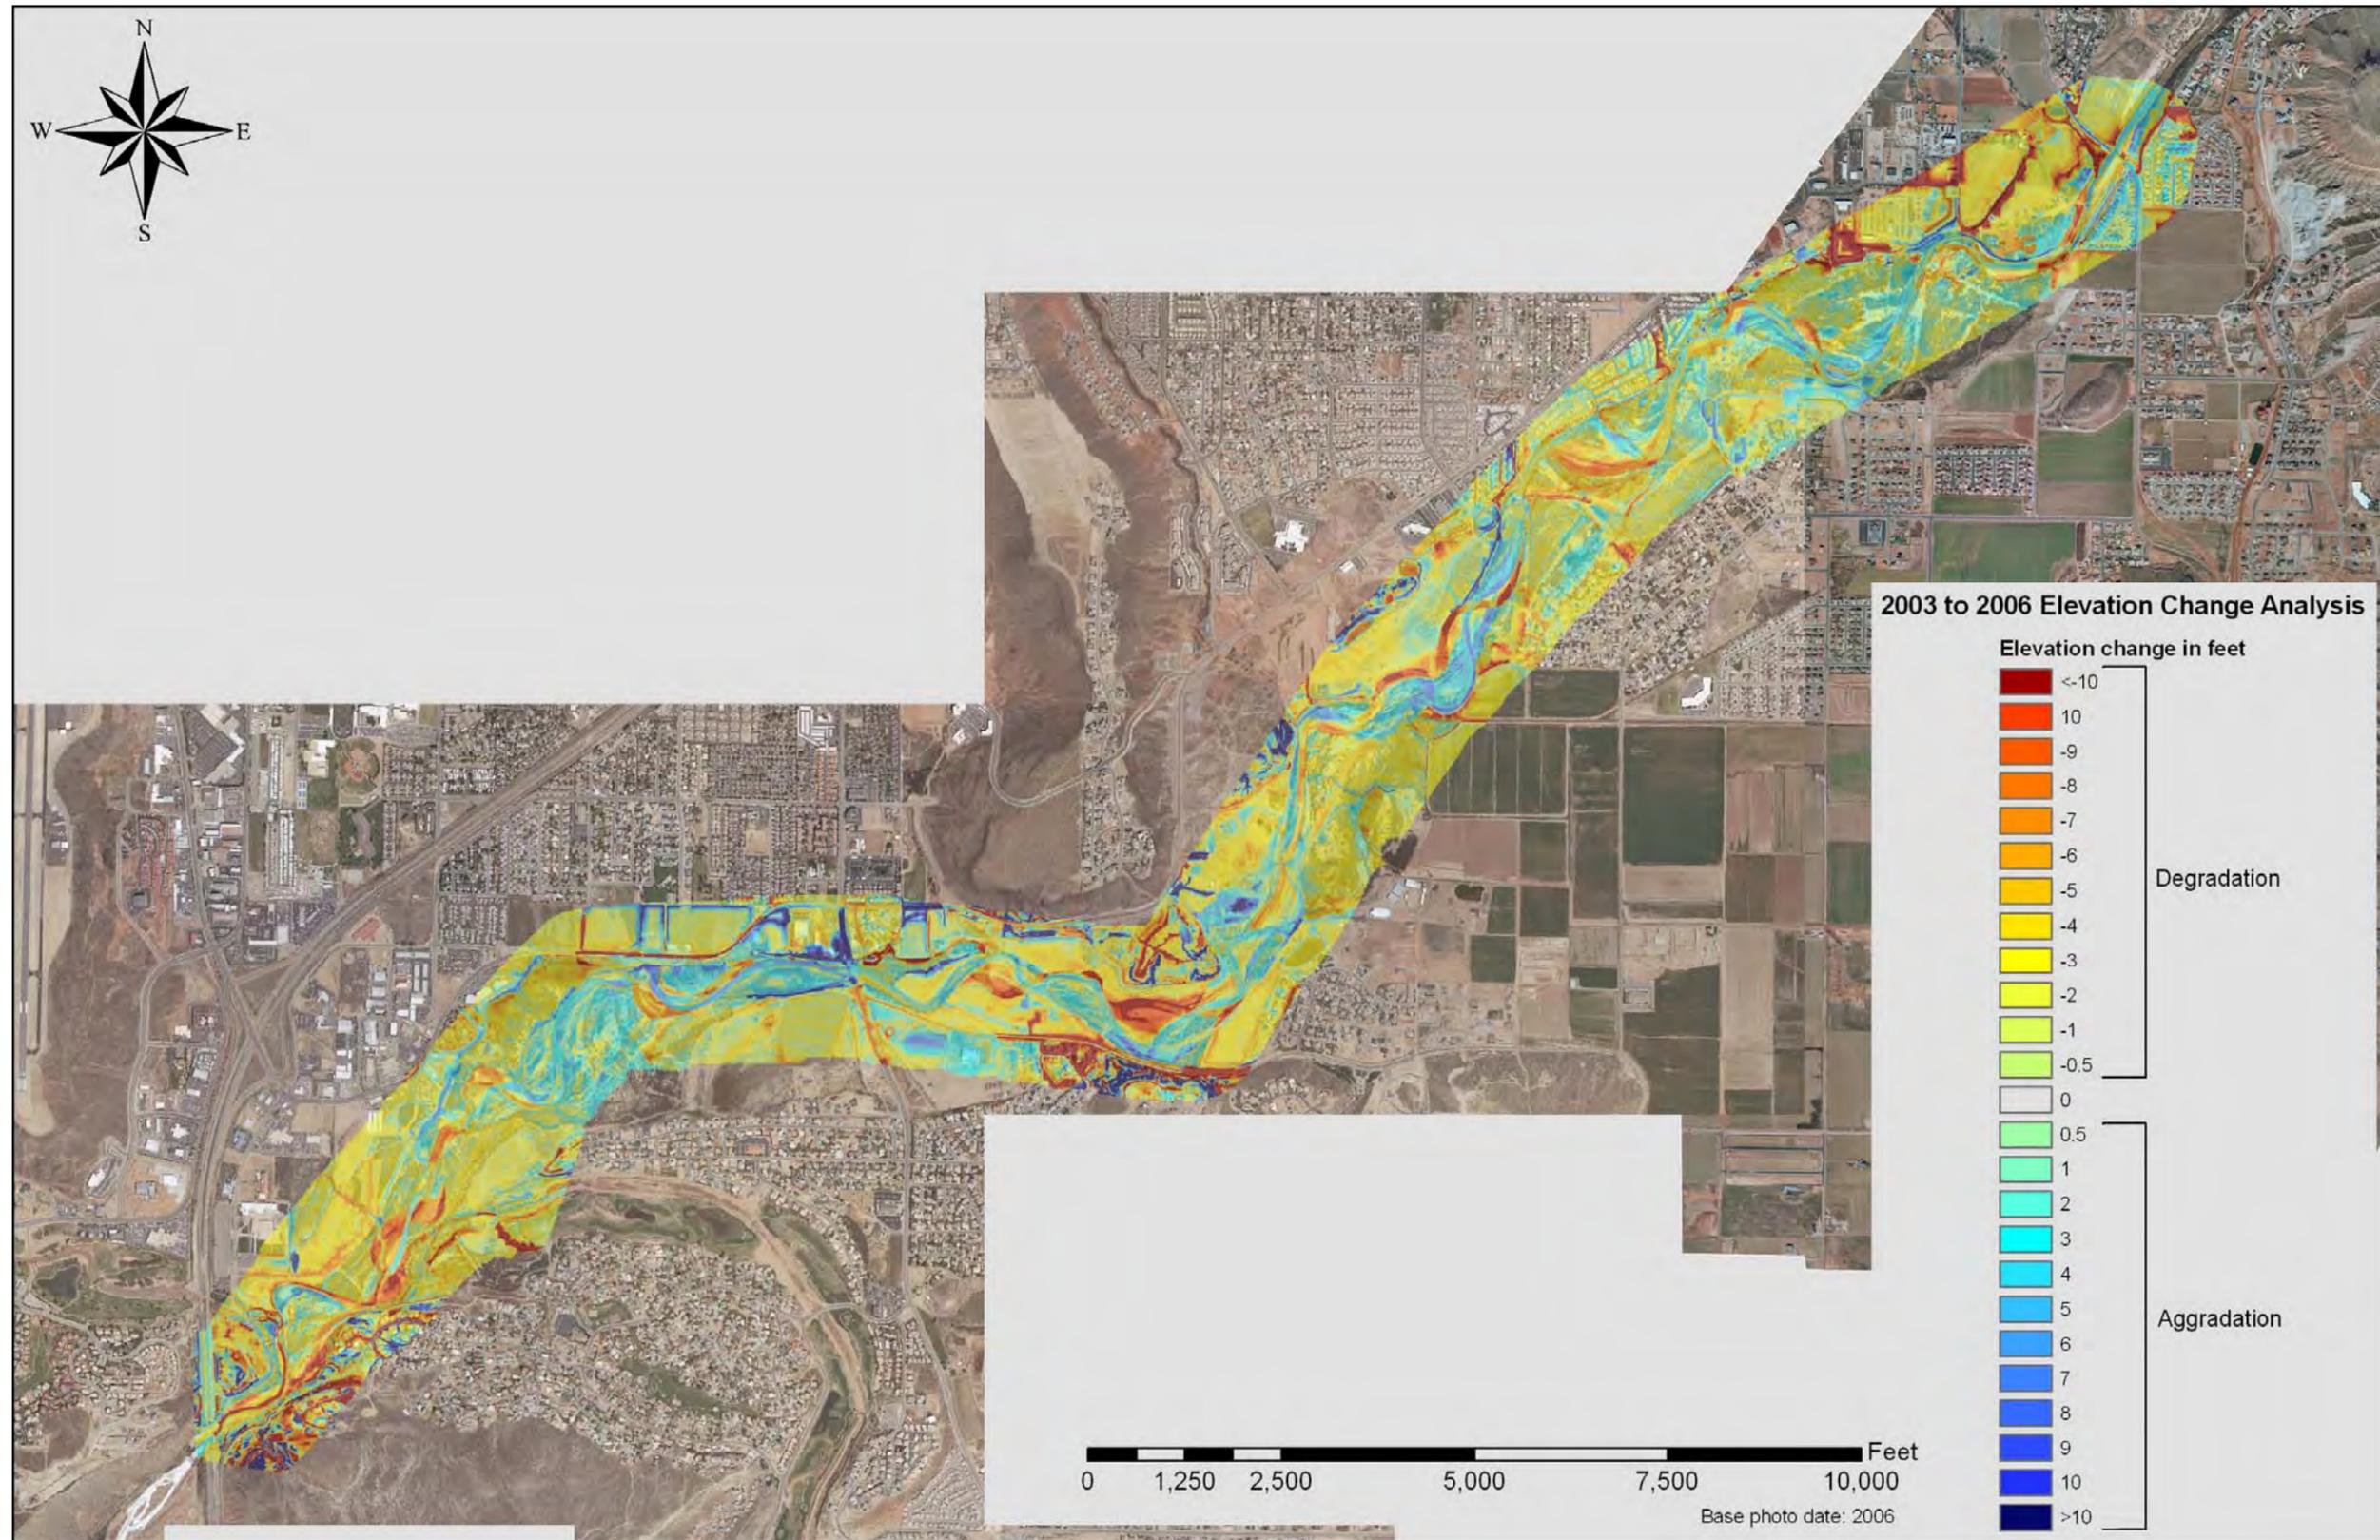
Figure 14. 2003 to 2006 elevation change analysis results

Quantification of elevation change from the 2005 flood was conducted utilizing the 2003 and 2006 mapping data (Figure 14). The plot clearly identifies the changes in both width and depth of the active channel, and when compared with the pre-flood channel position, shows locations of significant lateral channel migration. The plot also shows the extent of aggradation in the floodplain outside the active channel meander corridor.

The analysis shows several, site-specific areas that appeared to have experienced between 12 and 14 feet of degradation (shown in dark red on Figure 14). The figure can be somewhat misleading with respect to the active channel by suggesting that some areas experienced significant scour, when the process was actually lateral migration. Since the elevation data is a snapshot in time, changes in the lateral position of the channel between data sets will result in apparent aggradation, when in reality the channel migrated laterally and the former location of the channel subsequently became floodplain, likely filling-in with flood deposits and vegetation (shown as aggradation). The new location of the channel is expressed as degradation in Figure 14 when in reality the active channel migrated through the former floodplain, eroding the bank and removing floodplain sediment which gives the appearance of floodplain degradation.

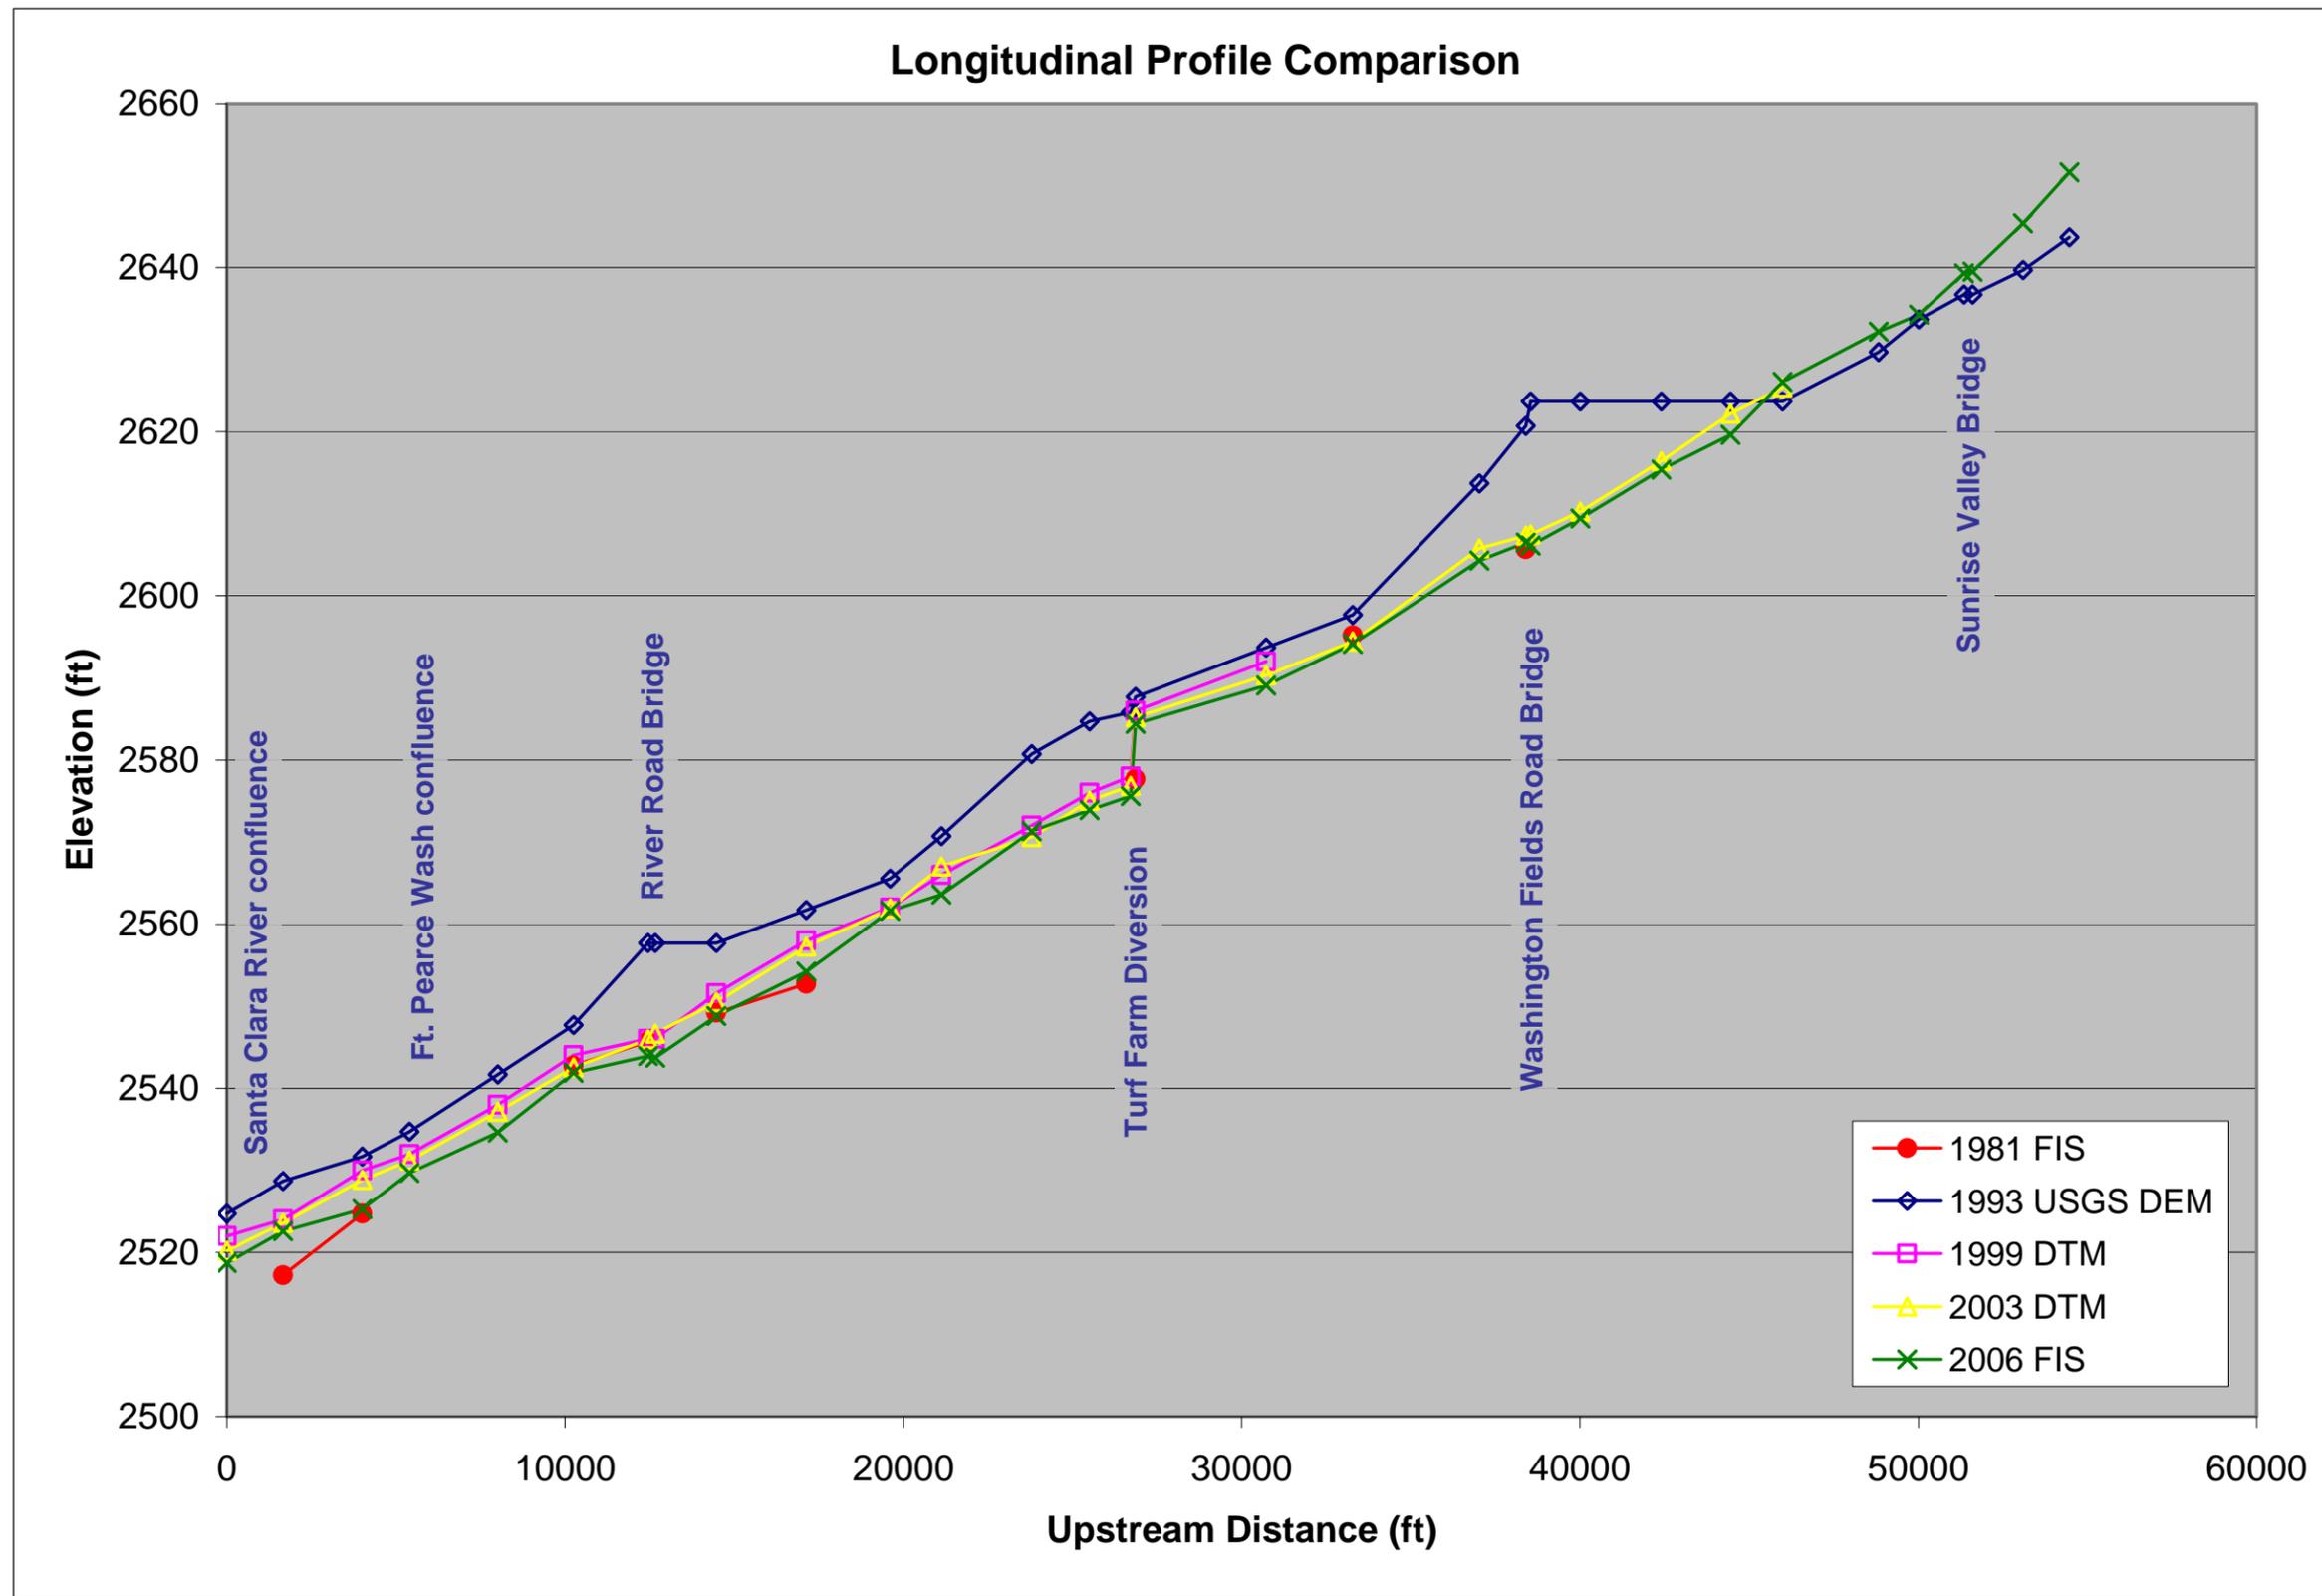
Figure 16. Longitudinal profile comparison plot

The 1993 USGS DEM data plotted in Figure 16 is significantly different than the remainder of the data. These inconsistencies suggest that the data is suspect and is unlikely to be an accurate representation of the channel profile in 1993.

The plot shows that from 2003 to 2006 the Virgin River experienced a consistent degradation of the low-flow channel between two and three feet. The majority, if not all the degradation likely occurred during the 2005 flood. Given the size of the Virgin River watershed and the magnitude of the 2005 flood, it is remarkable that such minimal degradation occurred during the event.

The 1981 FIS data plots indicate the Virgin River has not experienced significant changes in bed elevation in the past 24 years. Within that 24-year period, the river experienced an unprecedented flood (60,000+ cfs) following the Quail Creek Dam failure, and the largest natural flood in the gage record in 2005 (19,600 cfs). These large magnitude events appear to have had little impact on the bed elevation. However, the 1981 data does show aggradation has occurred downstream of the Ft. Pearce Wash confluence. This is potentially caused by the influx of sediment from Ft. Pearce Wash over time.

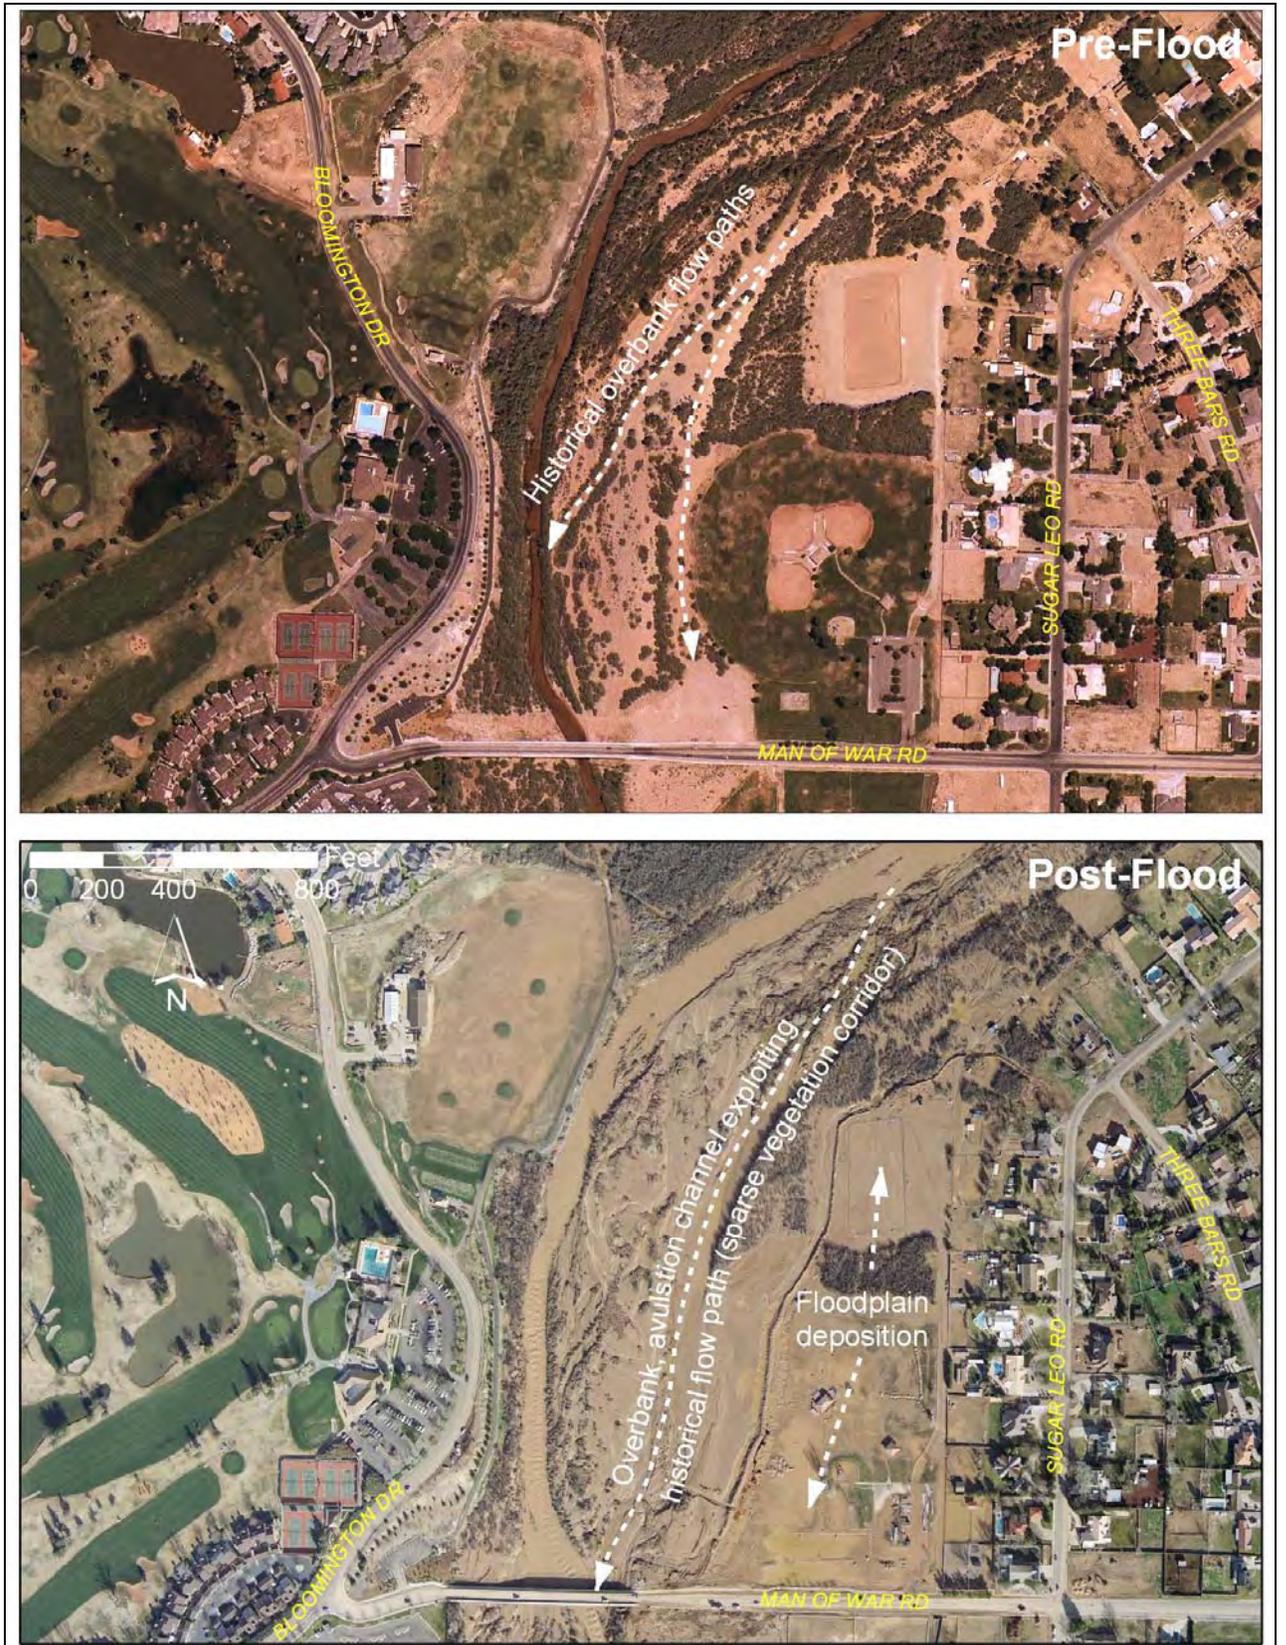
Figure 13. Virgin River upstream of Man-of-War bridge

The most severe changes in the Virgin River study reach occurred in the vicinity of the Man-of-War Bridge. Upstream of the Man-of-War Bridge, the pre-flood low-flow channel was characterized by a gradual, wide radius bend with dense vegetation adjacent to the low-flow channel with vegetation density decreasing outward across the left-overbank floodplain. Vegetation patterns in this overbank area indicated the presence of historical overbank flow channel across the surface. During the 2005 flood, overbank flows were able to concentrate in the overbank corridors where vegetation was sparse to nonexistent. This resulted in a near avulsion of the main flow channel and likely contributed to a larger volume of flow in the floodplain potentially resulting in greater amounts of sediment deposition. Figure 13 shows this location. Bank vegetation in this reach appears to have survived the flood and was moderately effective at stabilizing the low flow channel position.²

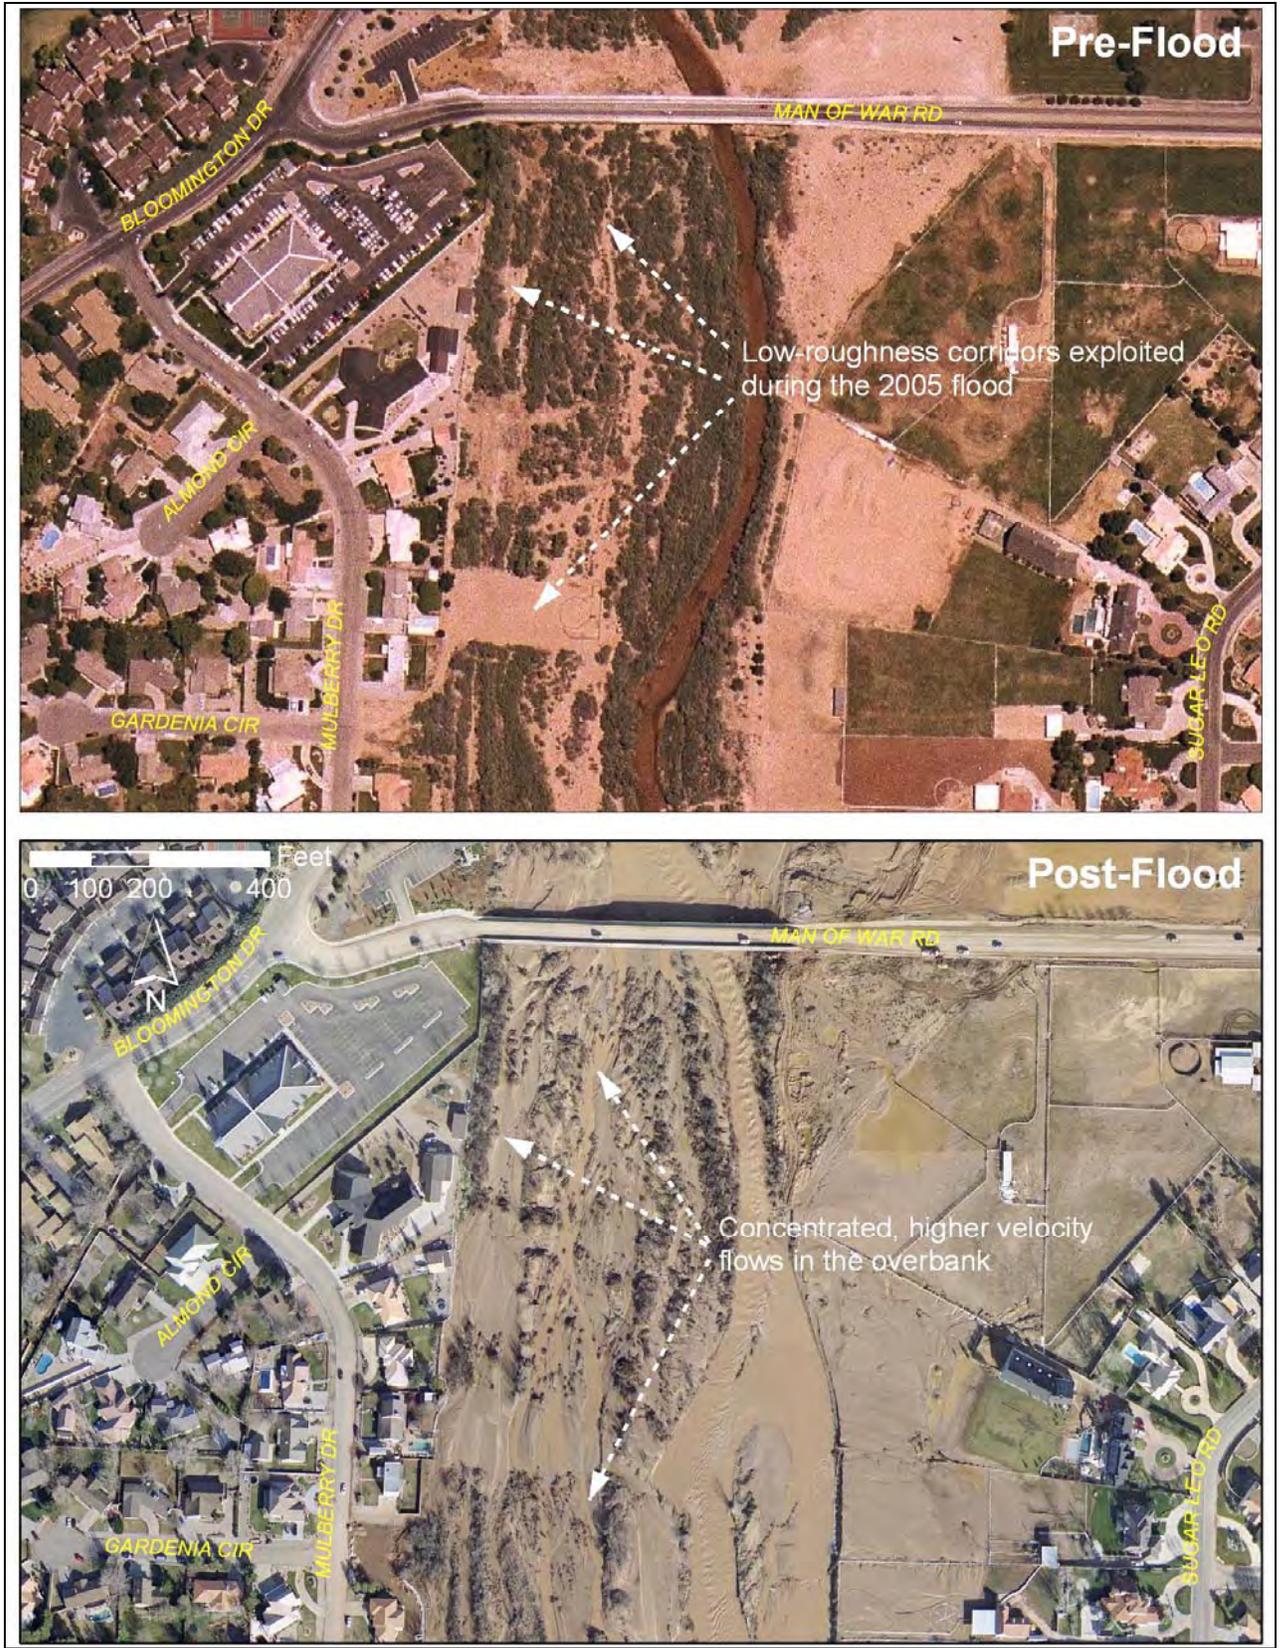
Figure 14. Virgin River downstream of Man-of-War bridge

Similar processes of change occurred downstream of Man-of-War bridge. Prior to the 2005 flood, the vegetation pattern of the right-overbank was characterized by dense thickets of Tamarisk with interwoven areas of no vegetation, and remnants of overbank flow channels. During the 2005 flood, overbank flows were able to exploit the low-roughness areas resulting in concentrated, higher velocity flows in the overbanks. Figure 14 shows the resulting overbank channel formation.

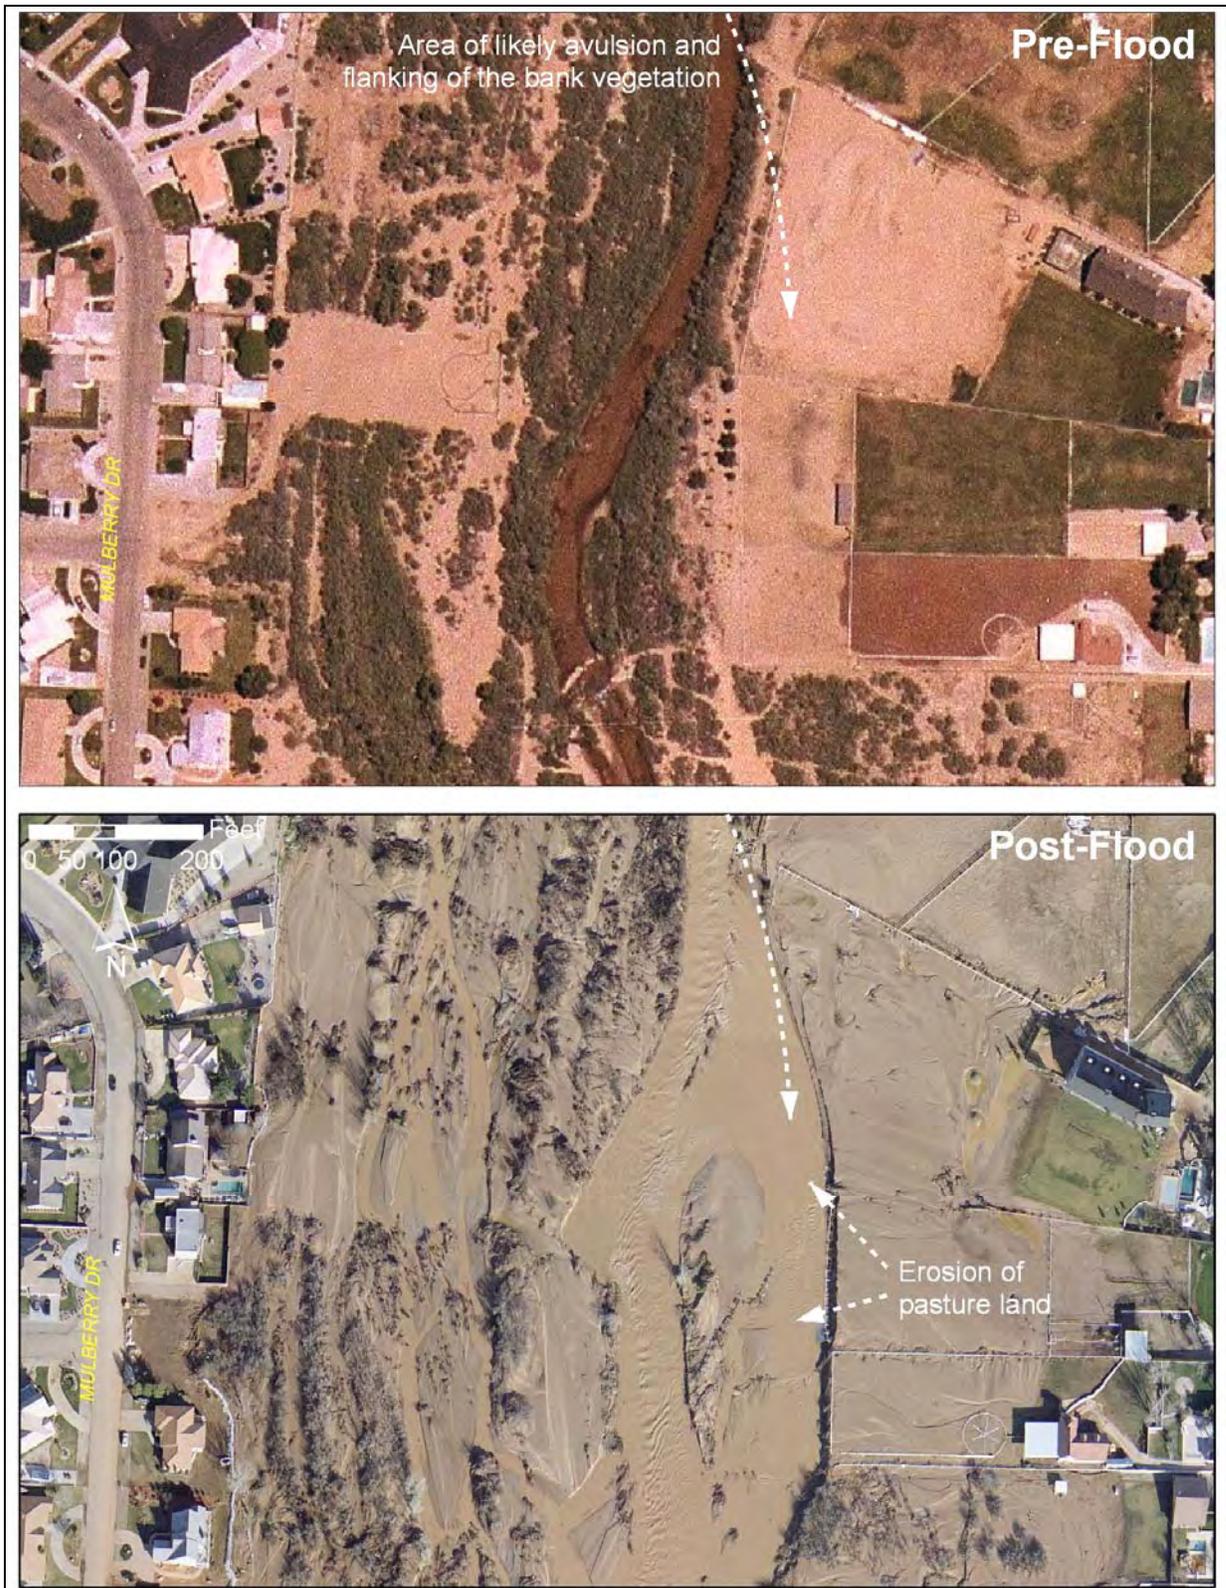
Figure 15. Lateral migration on the Virgin River downstream of Man-of-War bridge

Directly across the river from the area described above is the reach of the Virgin River that experienced the most significant lateral migration within the study area. Approximately 2 acres of pasture land were eroded by the flood. One likely explanation for erosion of the left bank is a flanking of the bank vegetation by overbank flows as occurred in multiple locations along the Santa Clara River (see Figure 11 and Figure 12). Once the flows were outside the rougher vegetation corridor, the smooth pasture land would have enabled high velocity, high energy flows to concentrate and erode the non-resistant soil. Figure 15 illustrates this potential explanation for the lateral migration in this area.
