Virgin River

Stability Study Update

Washington County, Utah

October 2007

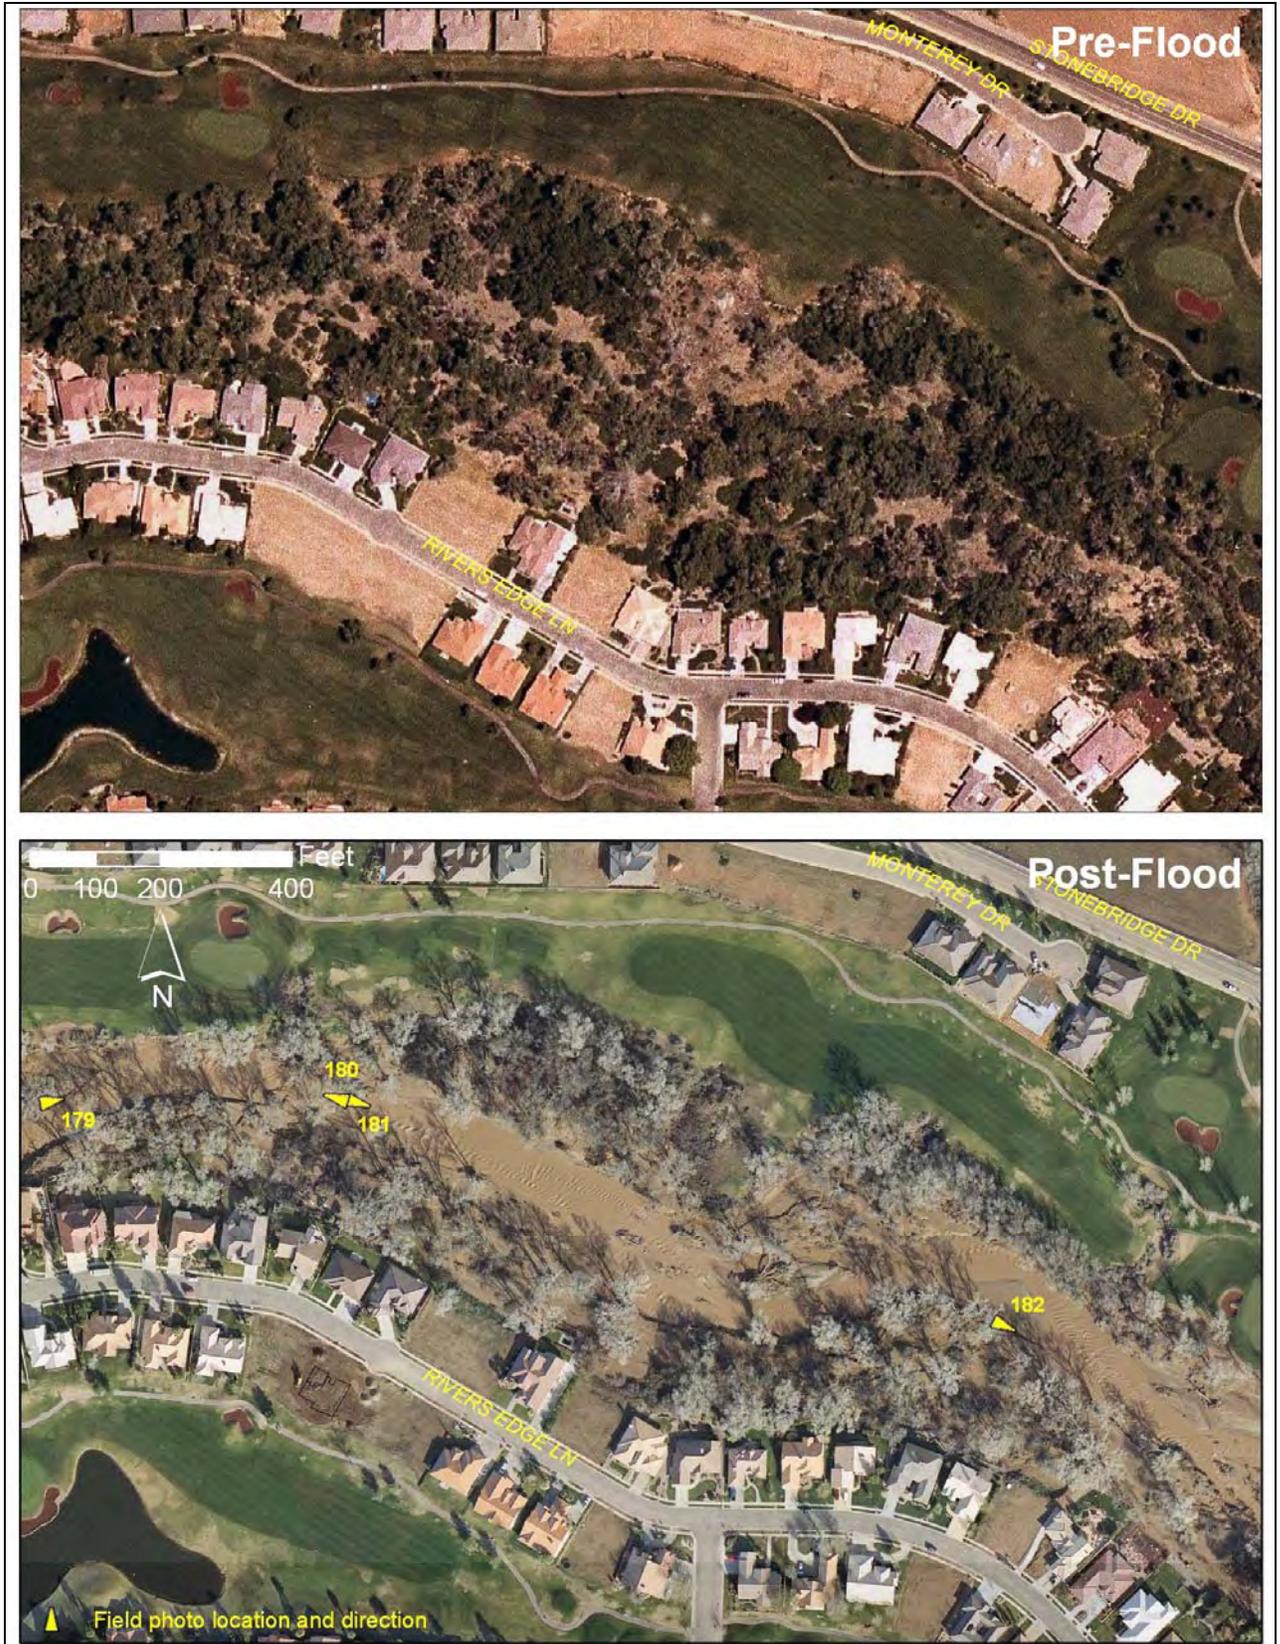
Figure 16. Stable reach near River's Edge subdivision

The first of these areas is a 0.3 mile reach located adjacent to the River's Edge and Stonebridge-Monterey subdivisions. The pre-flood condition of the reach was characterized by moderately dense stands of mature cottonwood trees in the overbanks and lining the low-flow channel. The distal margin of the right overbank floodplain was characterized by dense brush and shrubs up to the base of a 3/1, 6 ft high slope. The left overbank floodplain margin was characterized by moderately dense cottonwoods up to the base of a 10 ft high, densely vegetated, 3/1 slope. Figure 16 illustrates the pre- and post-flood condition of the reach. Figure 17 shows multiple ground photos taken during the field investigation (ground photo locations are shown in the post-flood photo in Figure 16). Another significant factor in the stability of this reach may have been the relatively high elevations of the floodplain above the main channel, which forced flood waters to remain over the main channel corridor as opposed to concentrating in low overbanks and creating avulsive or erosive channels. Note the lack of sediment deposition or other high water marks in Figure 16.

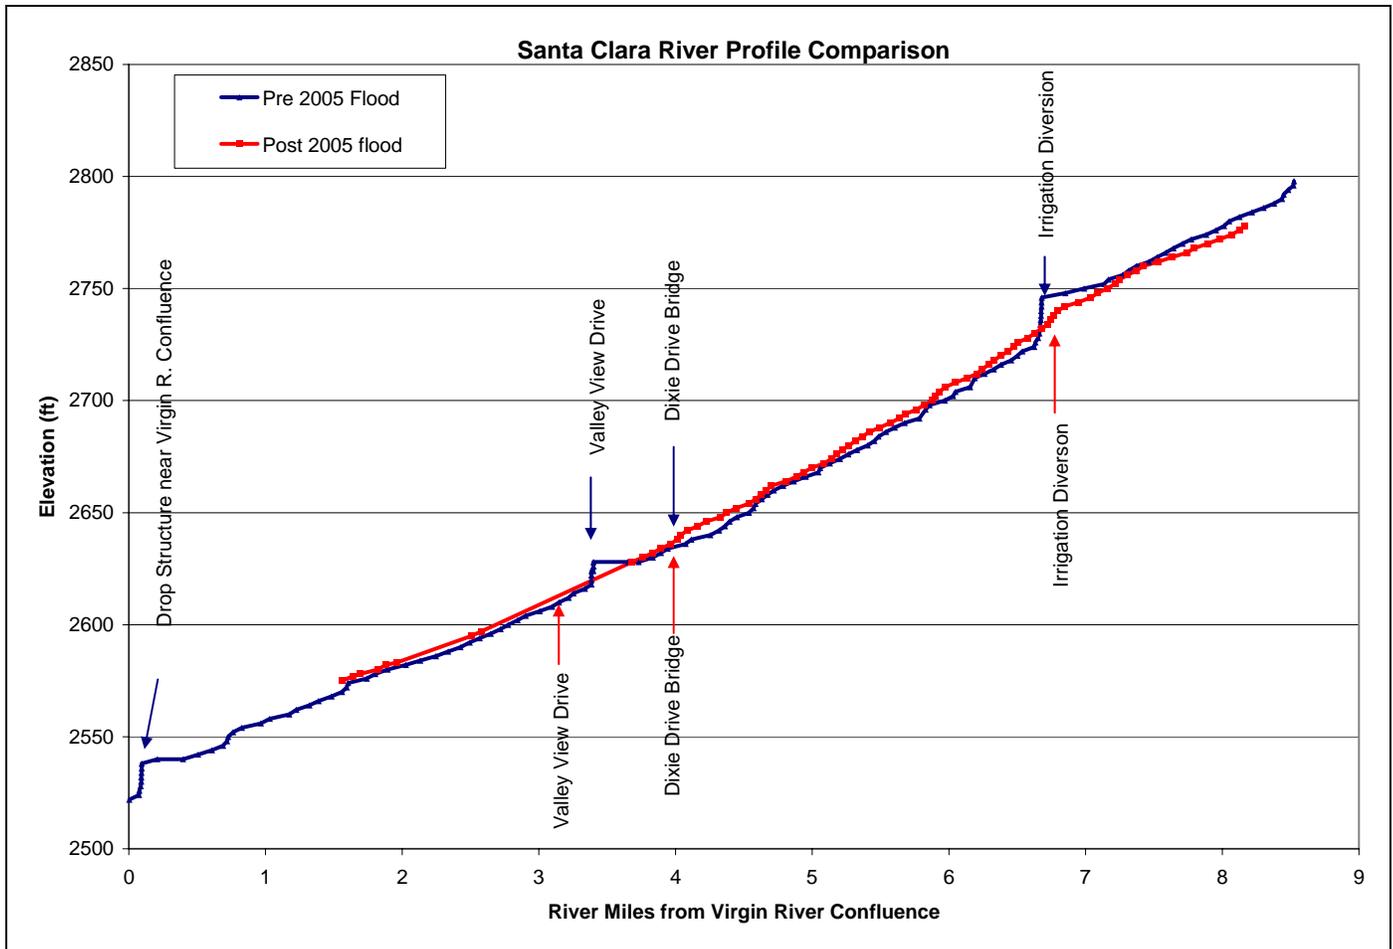
Figure 21. Santa Clara River profile analysis

Analysis of a pre-and post-flood channel longitudinal profile can provide information regarding areas of likely aggradation or degradation, channel instability, or other future changes in channel slope. A pre- and post-flood channel profile analysis was performed for the Santa Clara River within the study area as shown in Figure 21. The pre-flood profile data were derived from 1999 digital topography. The post-flood profile data were compiled from a combination of digital topography for the City of Santa Clara and surveyed cross-sections. The density of the cross-sections was significantly less than the topographic data, thus the post-flood point density downstream of Dixie Drive is lower

than upstream, as shown in Figure 21. Also, post-flood cross-sections were not surveyed for the lower 1.5 miles of river. Neither post-flood topography nor cross-section data for the Virgin River were available at the time this report was drafted. Therefore, a profile analysis was not completed for the Virgin River. As shown in Figure 21, the Santa Clara River appears to have experienced net aggradation, a somewhat surprising result given the historical evidence of net degradation and magnitude of erosion experienced during the flood. Exceptions to net degradation occurred upstream of the diversion dam and Valley View Drive where pre-flood constrictions had caused aggradation observed as breaks in the profile shown in Figure 21.

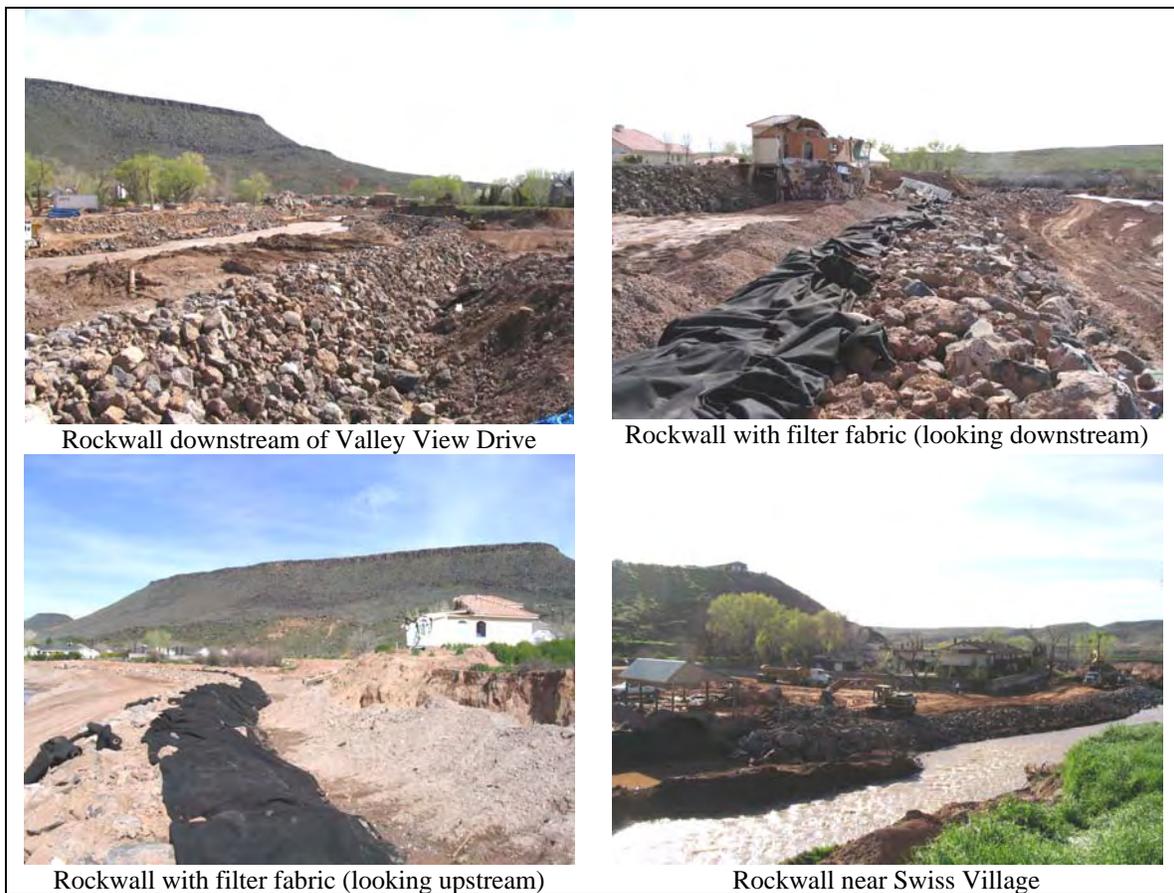
Figure 24. Ground photos of the NRCS rock wall construction

Immediately following the 2005 flood, the NRCS enacted an *Emergency Watershed Project* (EWP) for the Santa Clara and Virgin Rivers in the study area. The NRCS project consisted of debris removal and construction of over 25,500 linear feet of streambank protection along the Santa Clara River. The NRCS design consisted of rock wall levees, rock grade stabilizers, and rip-rap bank protection. Under the guidelines of the EWP Program, the NRCS stabilization was designed for the peak discharge of the 2005 event, rather than the 100-year (or larger) discharge that is used for most river engineering projects. Figure 22 shows the typical design detail for each type of erosion protection structure built by the NRCS, as well as a rock sizing table. Figure 23 shows the proposed locations of a portion of the NRCS structures on the Santa Clara River. Figure 24 shows ground photos of the construction of the rock levees.

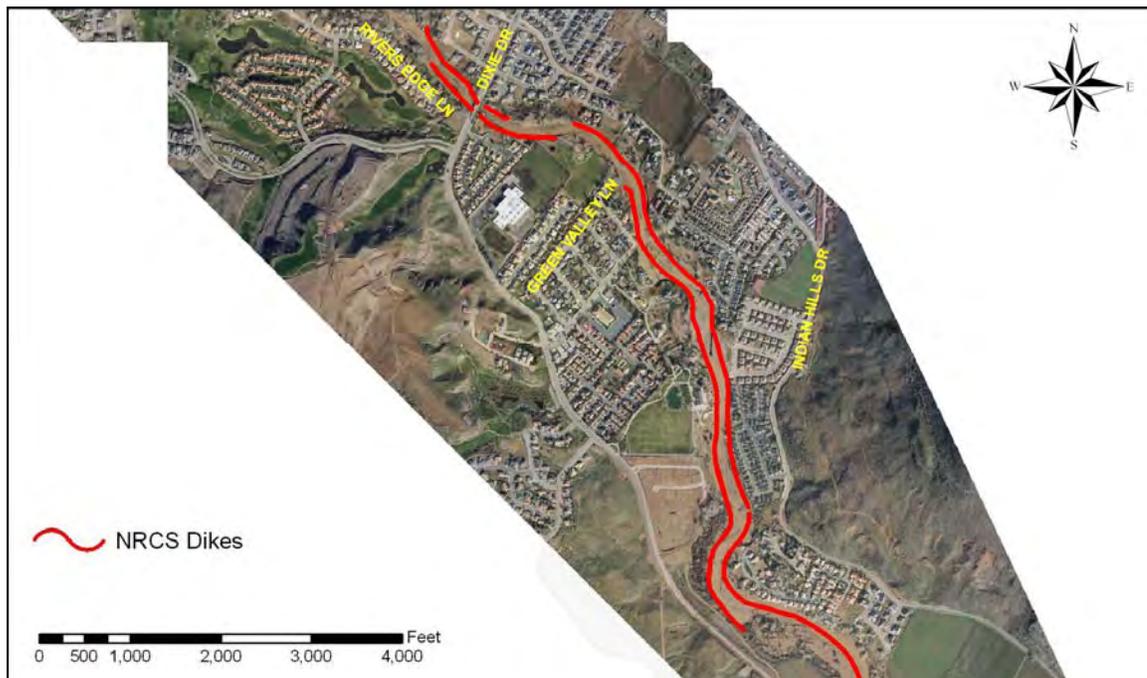
Figure 25. Scenario 1 - NRCS dikes on both banks

The NRCS dikes were constructed along both banks of the Santa Clara River for a 1.5-mile section beginning just upstream of the Mathis Bridge and extending about half-way through the Riverwood subdivision (Figure 25). This reach contains the most densely developed areas directly adjacent to the river corridor, and subsequently resulted in the most concentrated number of damaged and destroyed structures. The presence of the NRCS dikes greatly reduces the risk of lateral erosion from high frequency floods (e.g. 20-year and less). However lower frequency, higher magnitude floods (e.g. 50-year and greater) will overtop the dikes resulting in potential overbank flooding and erosion hazards. The following factors were evaluated in determining the location of the EHZ in the reach with NRCS dikes on both banks:

- Overtopping of the dikes – where sufficient data were available, hydraulic models were prepared to estimate the overbank depths and velocities when flows overtopped the dikes. Where overbank velocities were high (erosive), the EHZ location was adjusted to account for potential erosion of the bank slope above the dikes.

- Increased lateral erosion at the downstream end of the protected reach due to potential sediment deficits.
- Meander migration impacting the entry section of the protected reach.

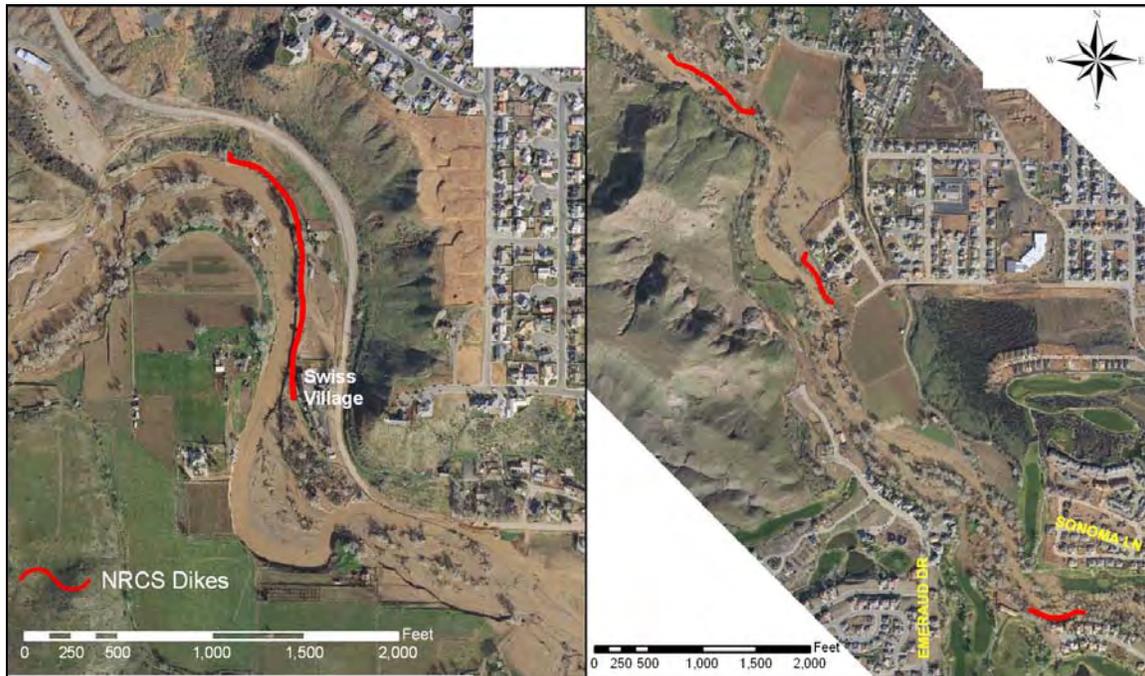
Figure 26. Scenario 2 - single-bank NRCS dikes

Single-bank dikes were constructed in multiple locations along both the left or right bank of the Santa Clara River. The single-bank dikes were built to the same specification as those in Scenario 1, thus the scour and overtopping considerations described above are also applicable. Figure 26 shows some of the locations of the single-bank dikes within the study area. An additional segment of single-bank dike was constructed downstream of the Scenario 1 area and is shown in Figure 25.

- The same factors as Scenario 1 were applied to the banks with single dikes
- The presence of any geologic control or erosion-resistant sediments along the unprotected bank
- The potential for future debris dam blockage
- The potential for channel avulsions and/or vegetation flanking
- The potential for preferential erosion of the non-protected bank
- The potential for reflective scour downstream of a protected bank
